Centennial HOA Exterior Renovations  
Proposal.

BUILDING ENCLOSURE INVESTIGATION AND ANALYSIS  
CENTENNIAL CONDOMINIUMS  
ASPEN, CO

2011.02.21

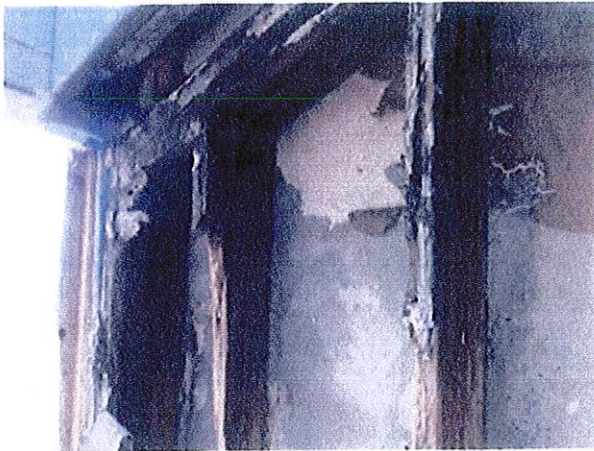
- During this work most of the studs, plywood sheathing, exterior gypsum board sheathing, insulation, structural headers etc. were found to be mostly rotten and needed to be replaced.

**Figure 3: Porch Exterior Wall (photo courtesy of REG)**

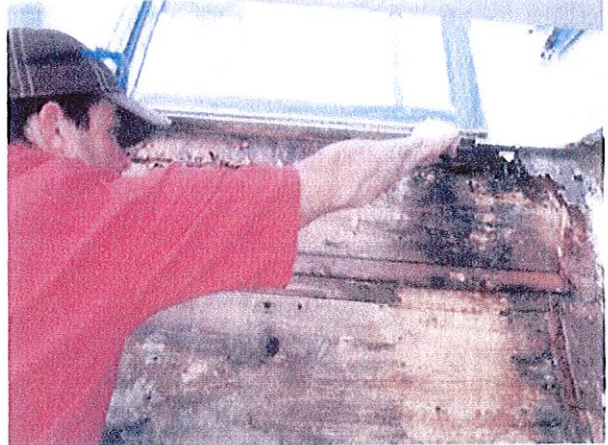
**Figure 4: South Header (photo courtesy of REG)**

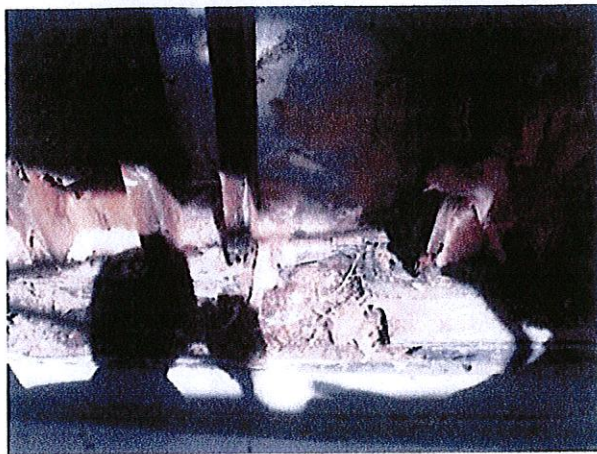
- The sill plate at the east facing wall (north side of the unit) was completely rotted out.
- To complete this 'exterior wall' scope of work, the kitchen and bathroom both had to be almost completely removed because of the moisture damage to the floor system and partition wall.

**Figure 5: Typical first floor sill plate at east wall of 314 (photo courtesy of REG)**

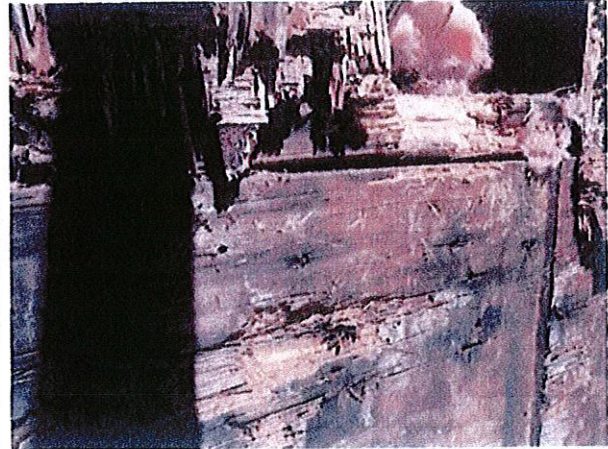
**Figure 6: LVL beam supporting cantilever of unit above unit 314 (photo courtesy of REG)**

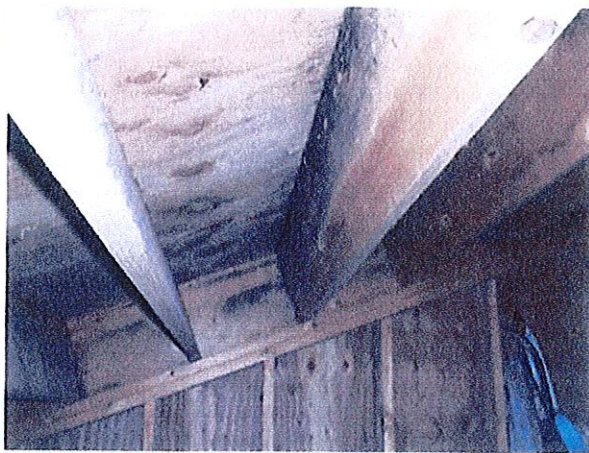
There was no observed evidence of water intrusion in the attic. However, there were multiple locations of condensation staining on the framing close to the roof or exterior wall sheathing (See Figure 11). Evidence of condensation was most significant near the dryer vent attachment to the exterior wall (See Figure 12).

**Figure 11: Attic condensation stains**

The resulting moisture load is greater than can be managed by the ventilation scheme. As a result, condensation accumulates at various places on sheathing and framing at the exterior surfaces.

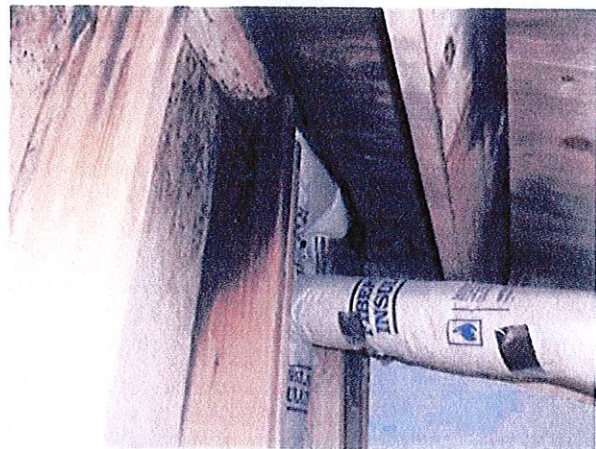
**Figure 12: Attic condensation stains at dryer vent**

addition to the air leakage from the interior space, there is concern relating to moisture loading of the attic from bathroom fans and dryer exhaust (as was observed in the unit investigated).

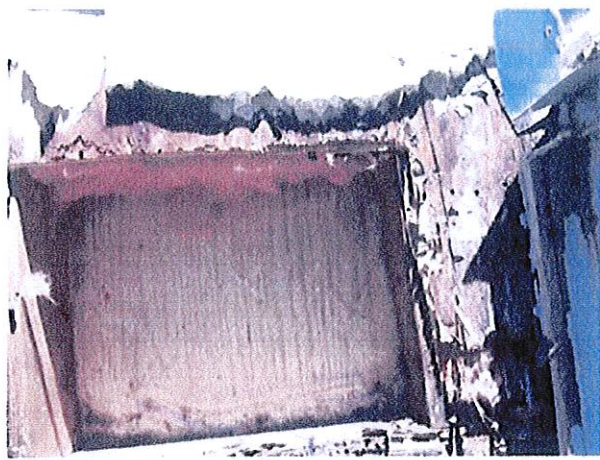
**Figure 17: Investigation at wall/wall connection**

The investigation was continued at this location by removing the siding down along the wall-to-wall connection at the exterior of the storage closet. Here, the exterior gypsum board was water damaged and crumbled. This extended out approximately 12" from the wall-to-wall intersection. Since the plywood sheathing showed water staining, a cut was made in the plywood to investigate the wall structure. No damage to the studs was evident at this location (See Figure 17).

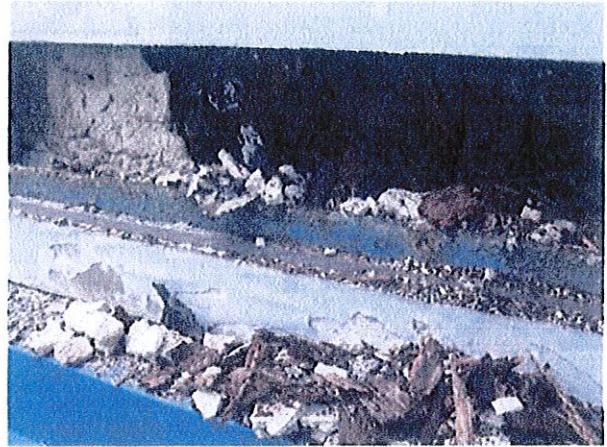
**Figure 18: Investigation at base of wall**

The siding was then removed at the base of this exterior wall. Here extensive damage was observed with both the exterior gypsum board and the plywood crumbling and evidence of rot along the outside edge the wall studs and sill plates (See Figure 18). Note that at this location, the concrete foundation wall and sill plate is proud of the siding; metal flashing covers the extension. The flashing was noted to be sloped backwards in many locations directing water up against the building.

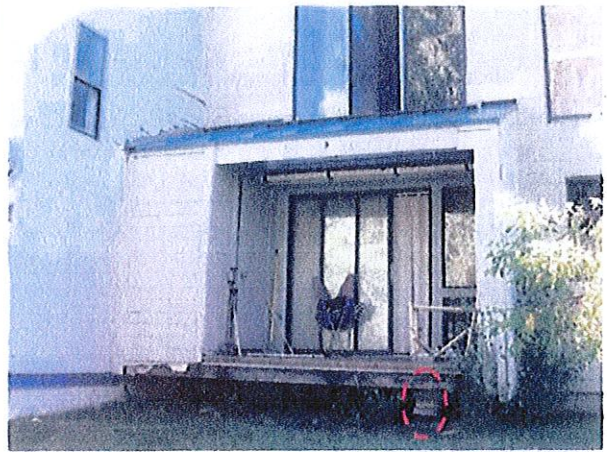
It should be noted that the first floor decks on the southwest side of the buildings were originally constructed as cantilevered structures. There was water damage reported in the past at the decks –all the original stairs were removed because of damage – and damage can be seen to the some of the structure underneath. (See Figure 19) In some cases, homeowners have added support underneath suggesting that the original decks may be sagging. (See Figure 20)

**Figure 20: SW porch with added "support"**

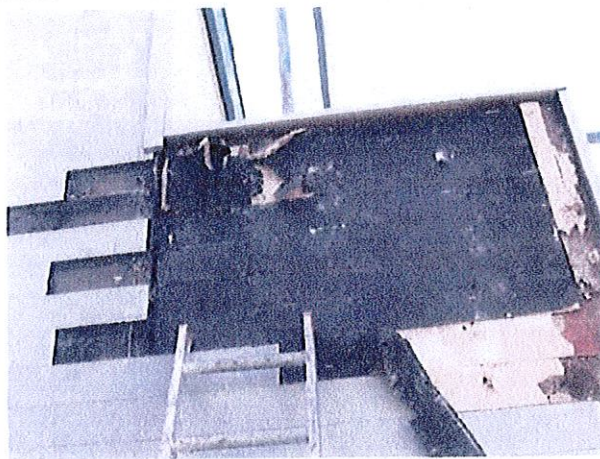
**Figure 23: Wing wall built over existing structure**

Without water proofing or flashing installed at the balcony wing walls, water is able to penetrate directly into the structure below. The removal of the wood siding at the wing wall to structural wall interface revealed a concentration of deteriorated material at the interface.

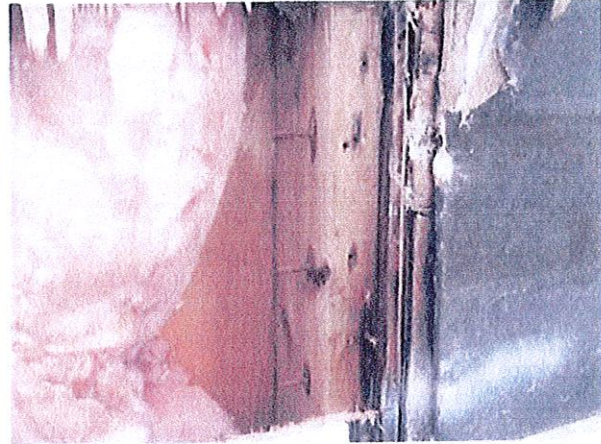
made through the plywood in the building wall at the connection point to see if the water damage extended into the wall. There was dampness felt in the stud space, but no damage to the stud could be seen (Figure 24).

**Figure 24: Wing wall attachment to building**

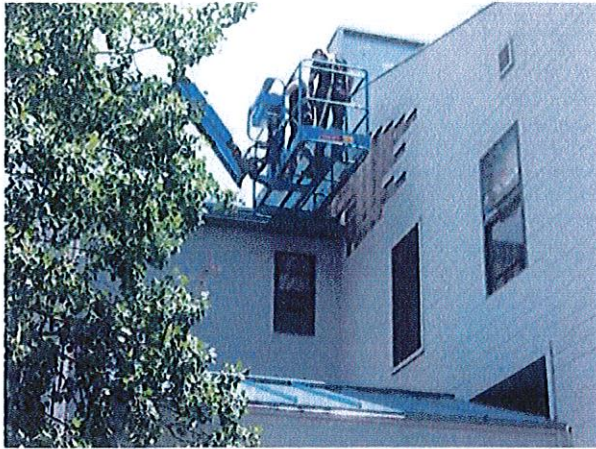
The next field disassembly was located at a roof/wall intersection along the northeast side of the building (Figure 25). The siding was removed so the condition of the wall could be examined (Figure 26). There was some water staining on the face of the exterior gypsum board causing peeling of its outer layer but the core was not damaged. The gypsum board was broken off to look at the plywood behind, which was not damaged. The roof/wall flashing detail was similar to that described earlier.

**Figure 25: Investigation at NE wall at roof/wall**

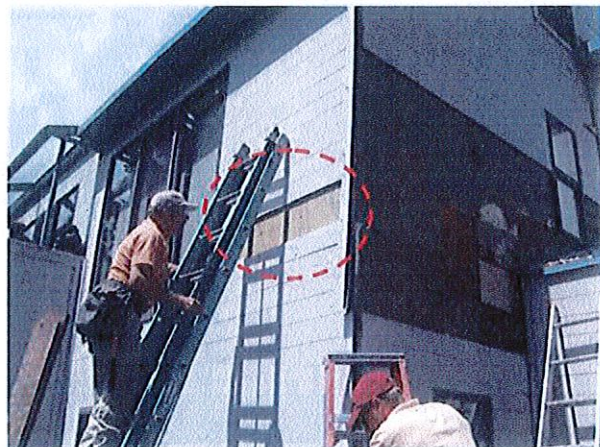
Additional investigation openings were made at two locations – in the wall field on a northeast wall and on a southeast wall. At the location on the northeast wall, when the siding was removed, some water stains could be seen on the face of the exterior gypsum board at siding nail penetration and around the windows, but there was no deterioration (See Figure 27). It should be noted that there is no overhang over this wall. On the other hand, along the southwest wall, where there is an overhang, no water staining of the exterior gypsum board was observed (See Figure 28).

**Figure 28: Investigation at SW wall (field)**

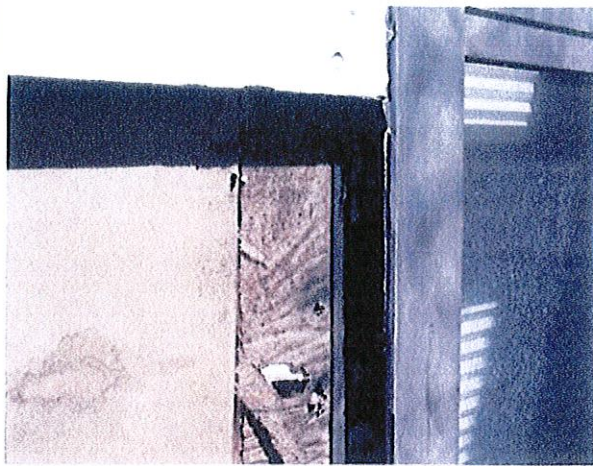
The windows from the original construction are still in place. They are double glazed windows and some are reported to be experiencing condensation within the glazing. The siding was removed at a window on the southwest side of the building (on a southeast facing wall) and at a window on the northeast side of the building to check for water damage around the windows (See Figure 29 and Figure 30). In both cases, the windows are on walls for which there is no overhang. There was no flashing observed at the windows (this lack of flashing was also noted at door heads, louvered vents, and mechanical penetrations). There was some water staining on the exterior gypsum board around both of the windows and on the plywood behind. The plywood was cut at the window on the northeast side to check for damage inside the wall, but none was observed.

Figure 29: Investigation at window (SE wall)

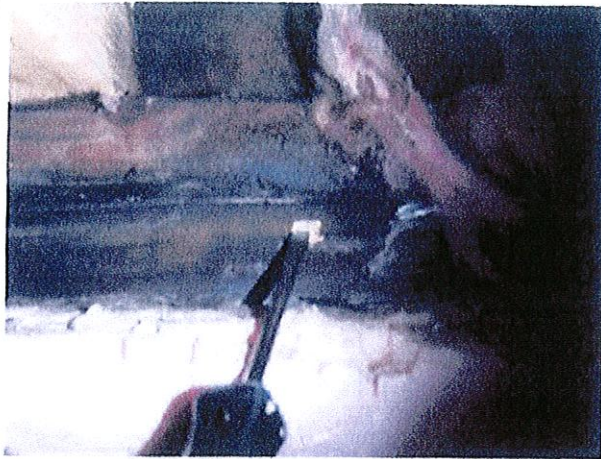
Additional information provided from REG did indicate areas where the sill plates and floor joists were observed to be stained and in some cases deteriorating. In addition some areas of the crawl were also noted to have insulation installed in the floor joists. The insulation appeared dirty and black.

**Figure 39: Deteriorating sill plates in 300 building crawl (photo courtesy of REG)**

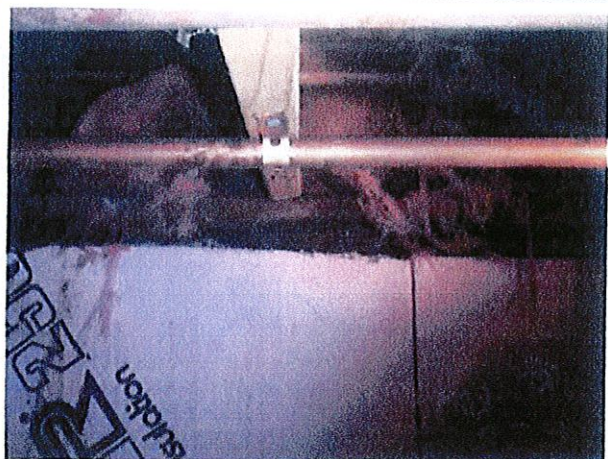
**Figure 40: Deteriorating sill plates in 300 building crawl (photo courtesy of REG)**

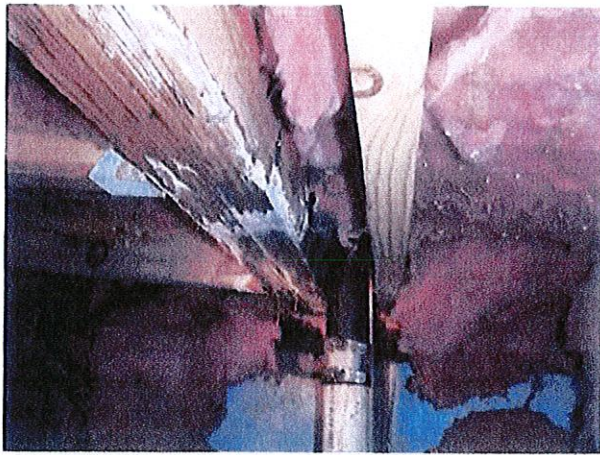
**Figure 41: Water staining on LVL beam (photo courtesy of REG)**

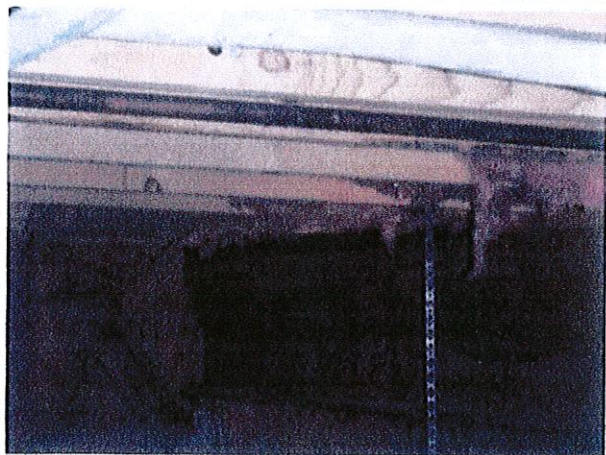
**Figure 42: Insulation falling out of floor joists (photo courtesy of REG)**

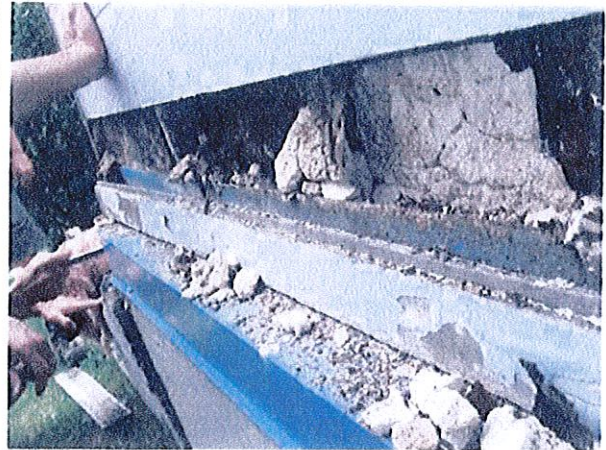
The leakage at the roof to wall connections is resulting in damage of the first floor structure where the wood frame structure is connected to the concrete foundation. The buildings are designed with the framing set back from the exterior edge of the foundation wall (Figure 44). This created a ledge for the water to accumulate at the base of the wall assembly. Removal of the siding material at the base of the southeast facing wall during the field investigation revealed that the framing had deteriorated (Figure 45).

Figure 45: Base of wall at foundation wall ledge
