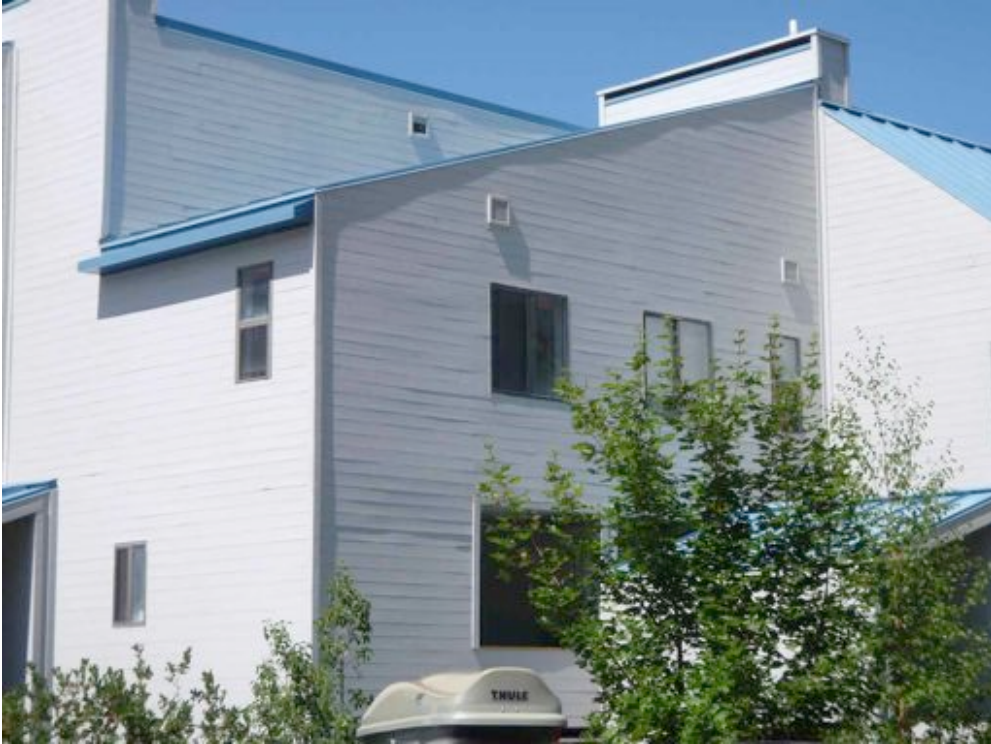
Fig 1: Typical exterior condition.

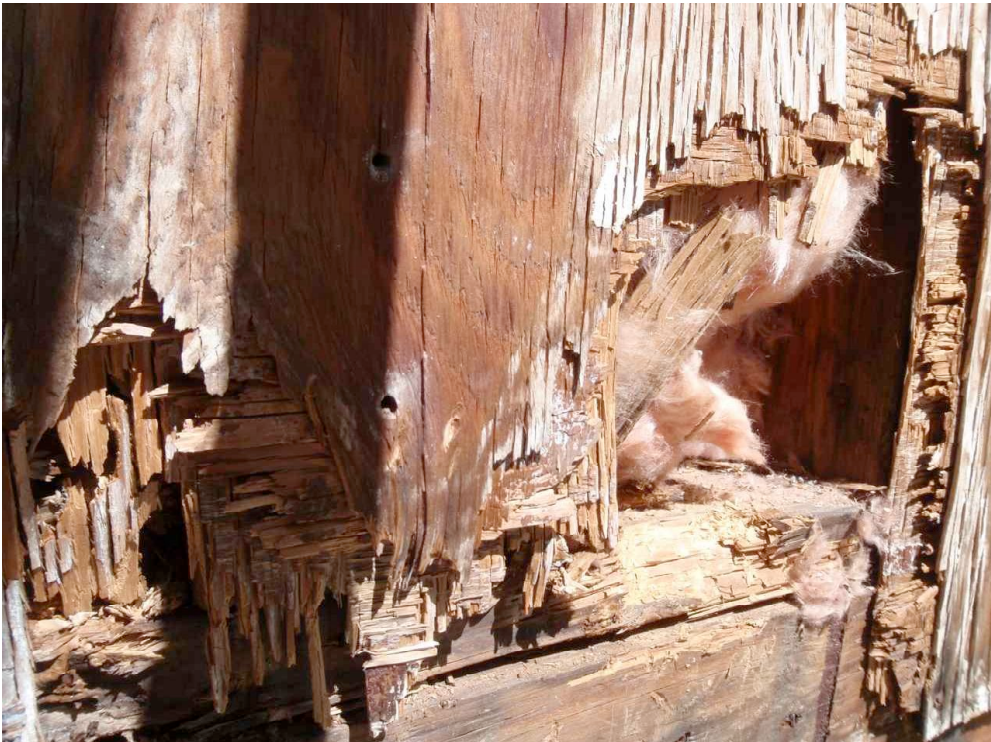
Fig 2: Exterior sheathing damage at unit 314.

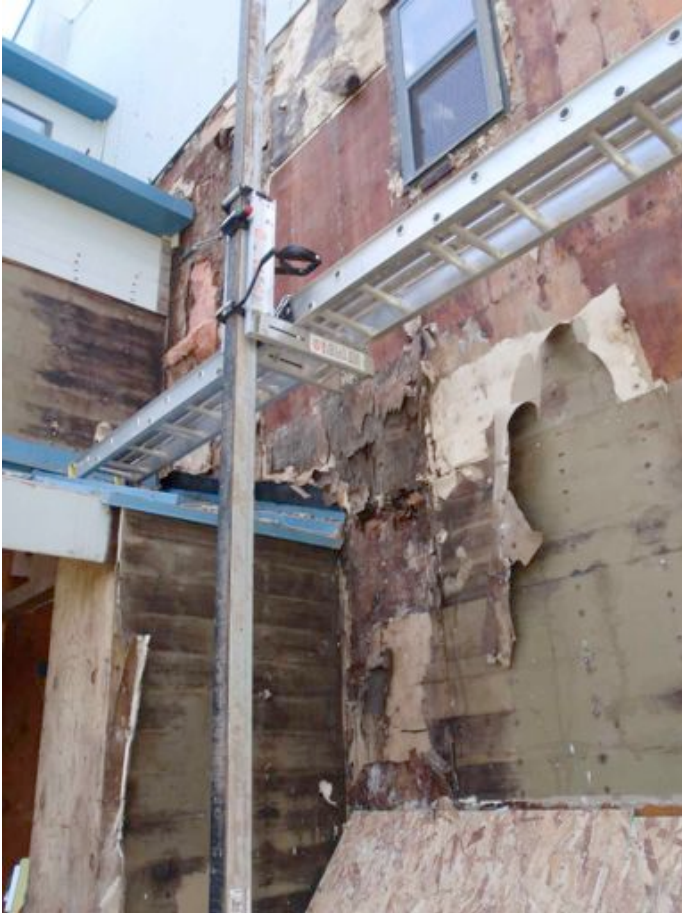
Fig 3: Siding removed with exterior drywall and sheathing exposed at unit 316.

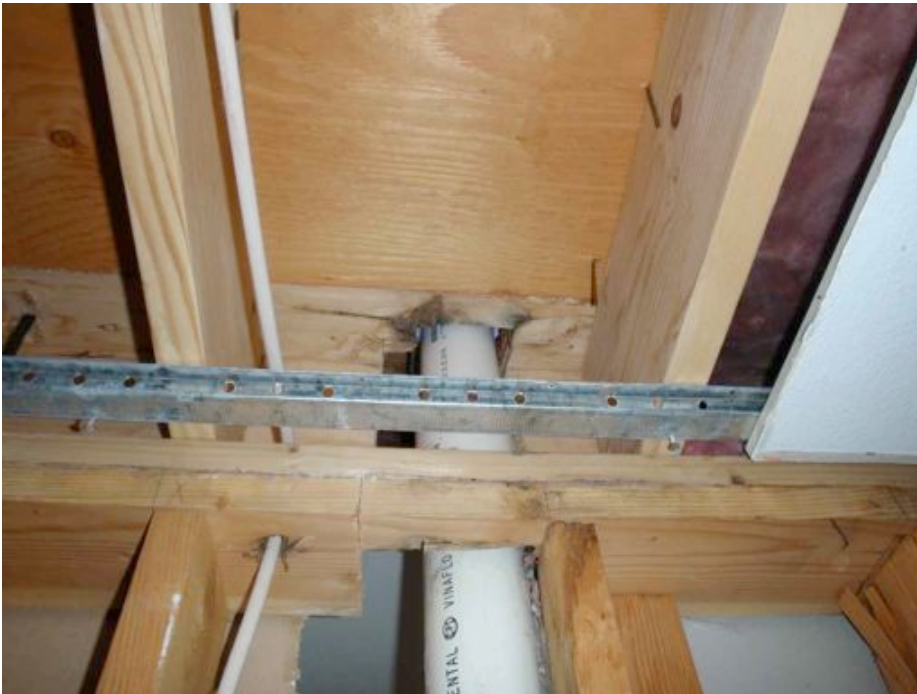
Fig: 4 Internal drain from above in unit 314/316 common wall. Source of leak.

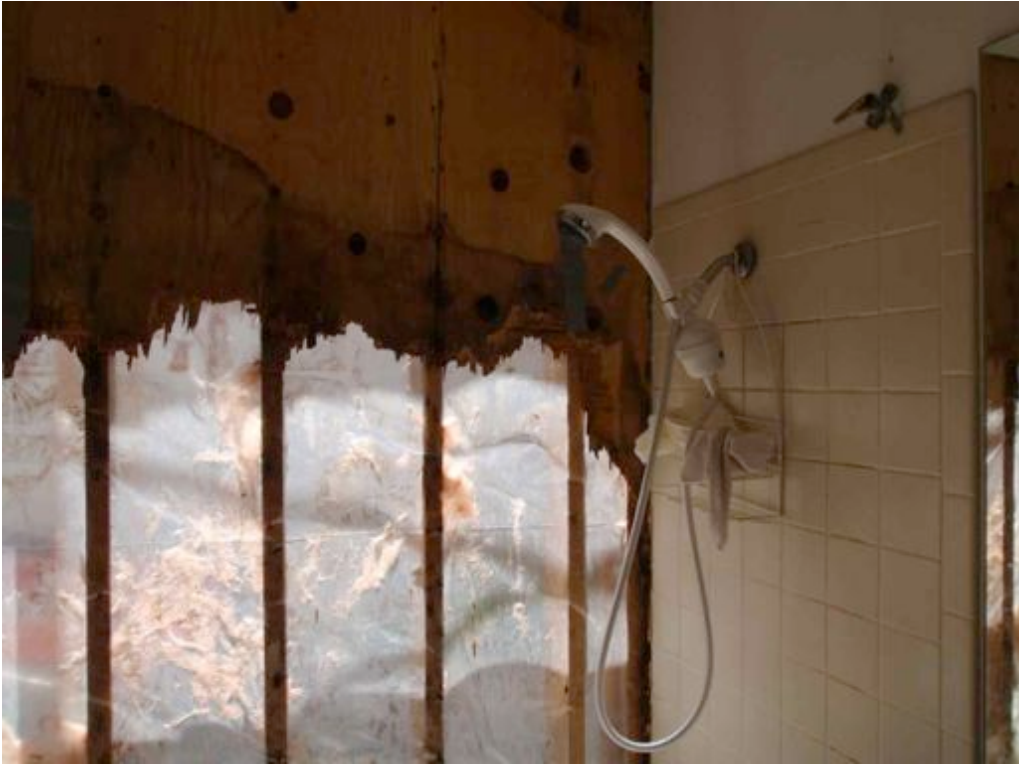
Fig 5: Moisture damage at showed enclosure in unit 314.

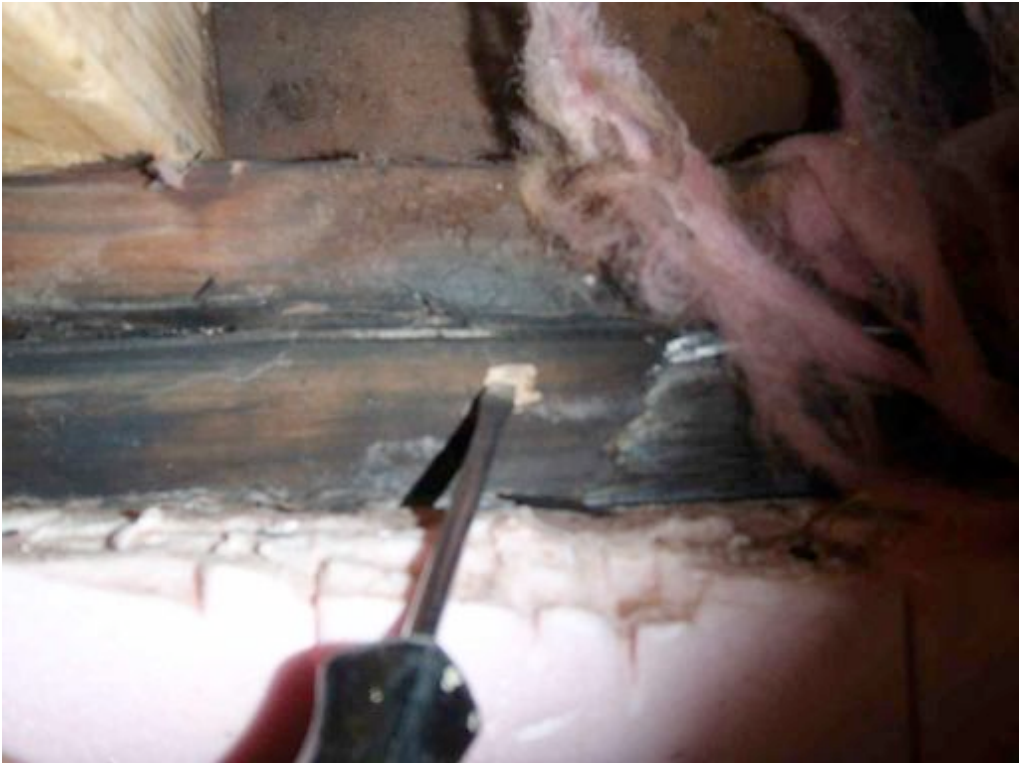
Fig 6: Sill plate in crawl below unit 314.

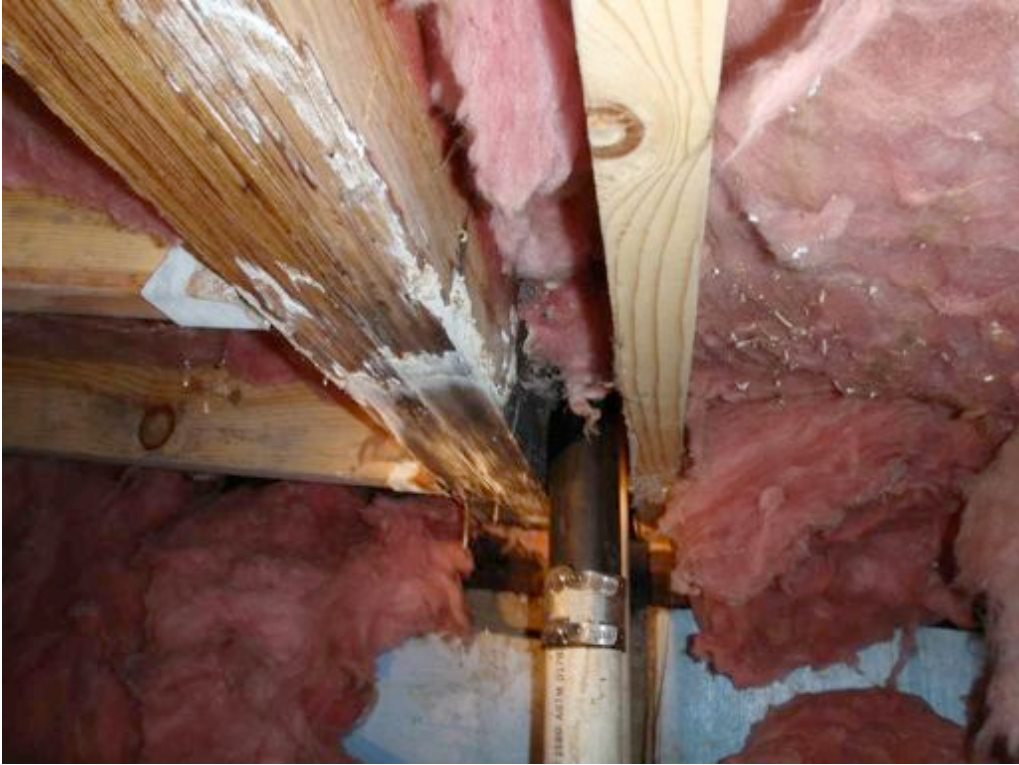
Fig 7: LVL beam showing multiple types of fungus. This photo was taken in the crawlspace, east of unit 316.

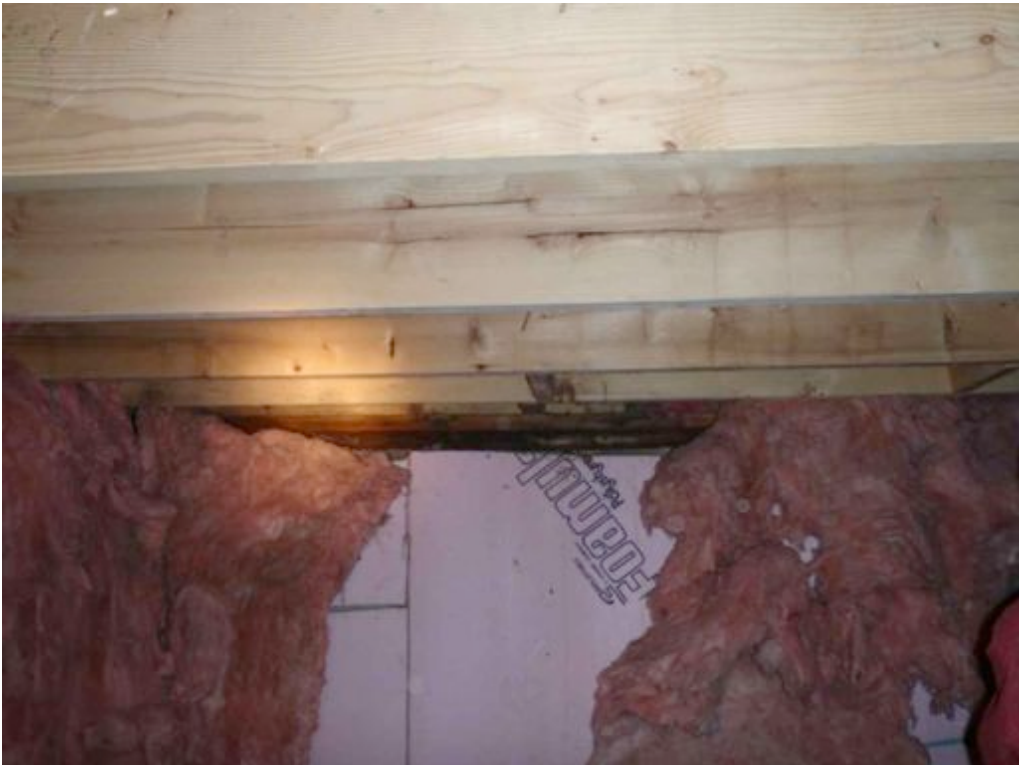
Fig 8: Typical sill plate damage in crawlspace.

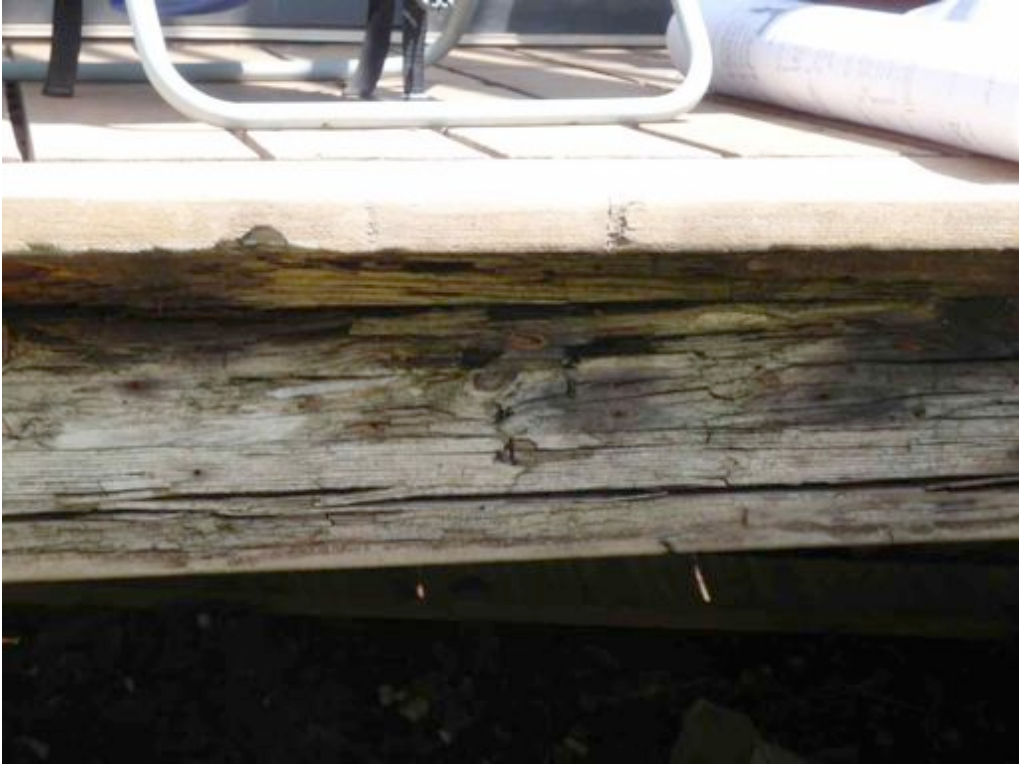
Fig 9: Typical porch edge beam.

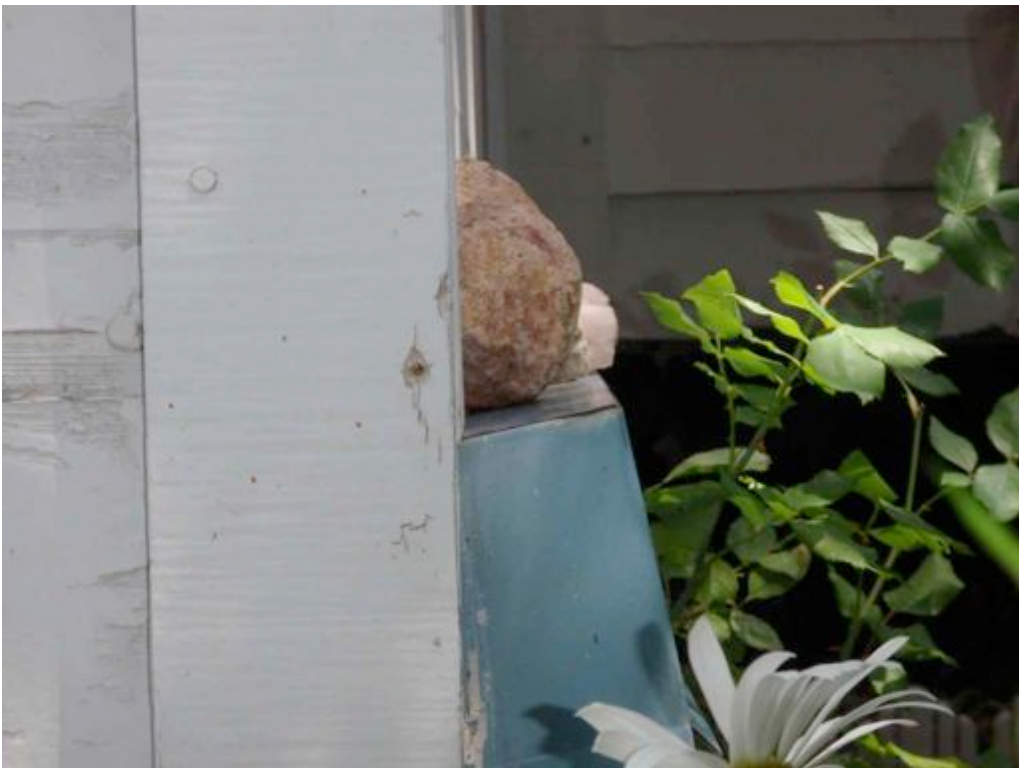
Fig 10: Typical flashing detail. Note how the flashing tips towards the wall rather than away. This is a result of faulty installation and/or the sill plate behind compressing.
