CENTENNIAL CONDOMINIUMS Concept Study

March 24, 2010

- Existing Conditions of the Complex
 - Inadequate Construction
 - Design Flaws
 - Value Engineering

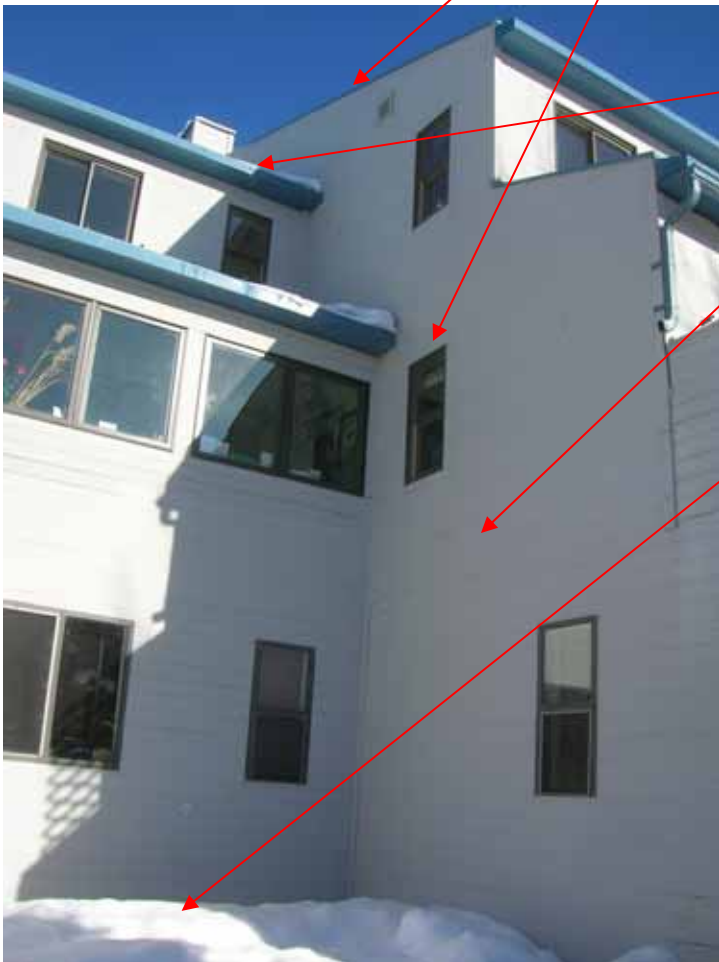
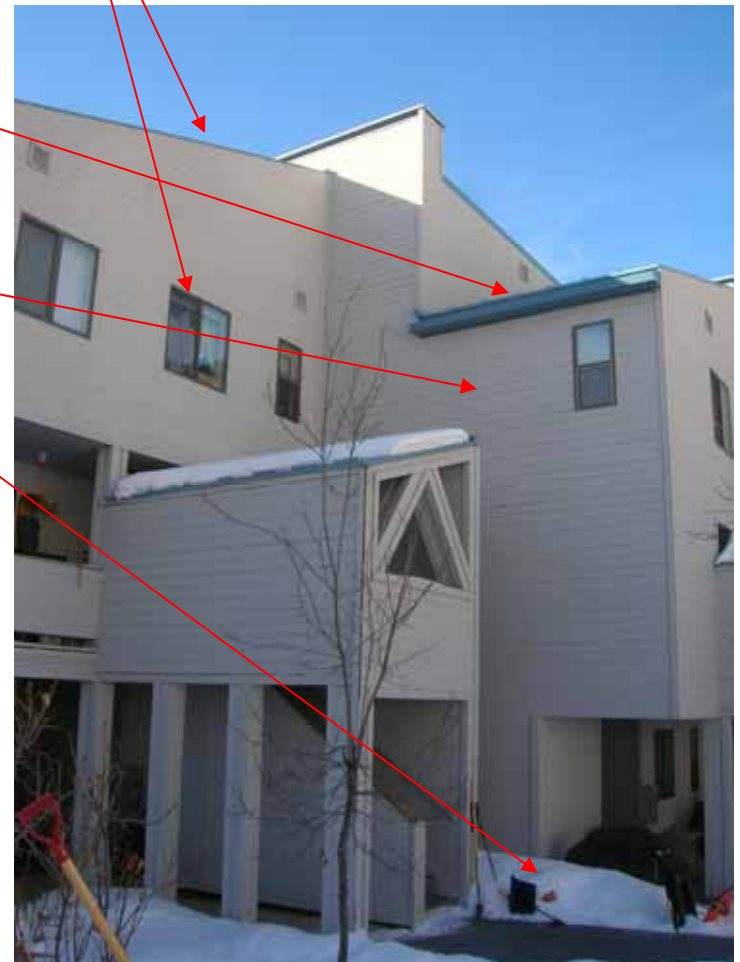
Sub Standard Roof and Flashing Installation

No Flashing installed at Windows and Doors

Inadequate Counter Flashing and Bituthene at Roof Transition

No Felt or Building Paper installed behind horizontal Tongue & Groove Siding

Snow and Rain Drop Zones create areas where water sits or splashes up against Building

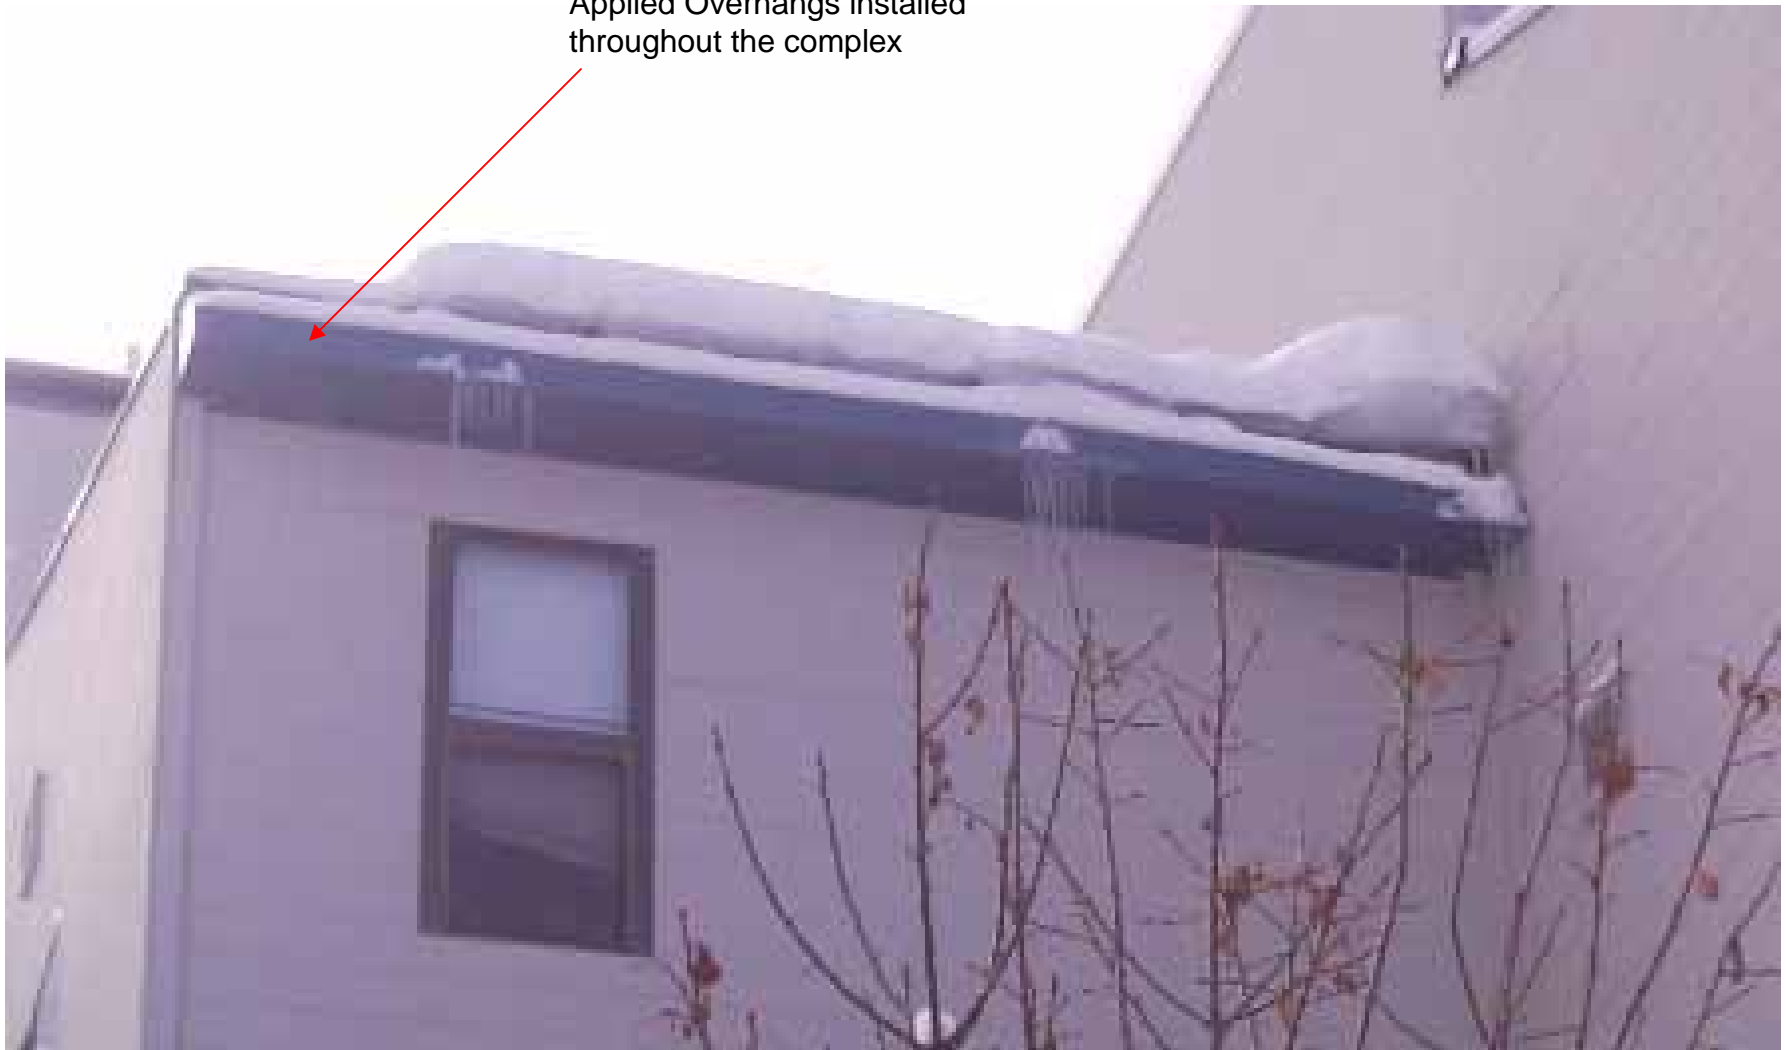
Applied Overhangs installed
throughout the complex

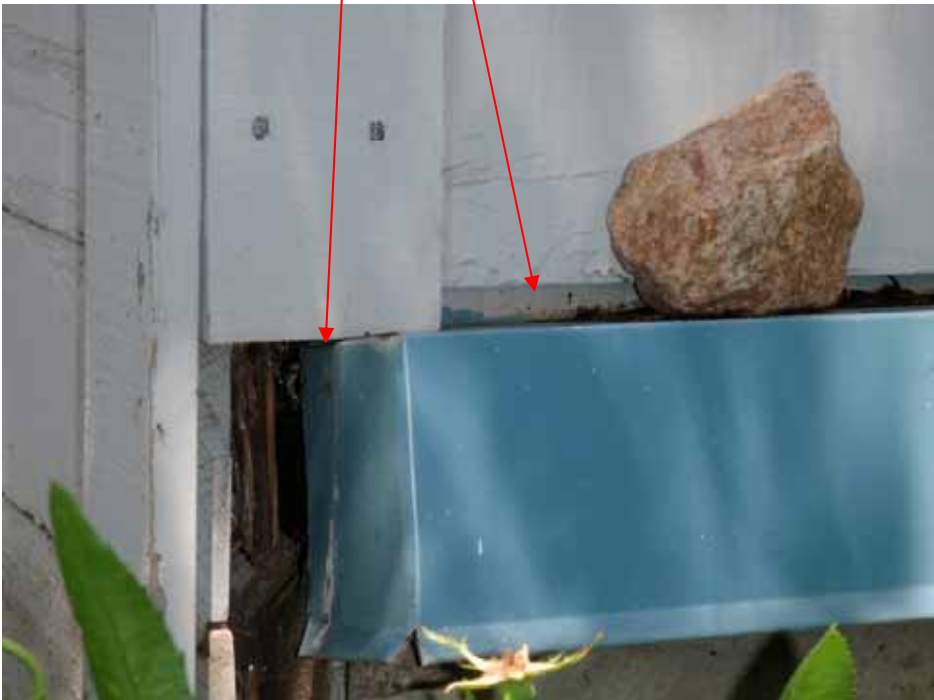
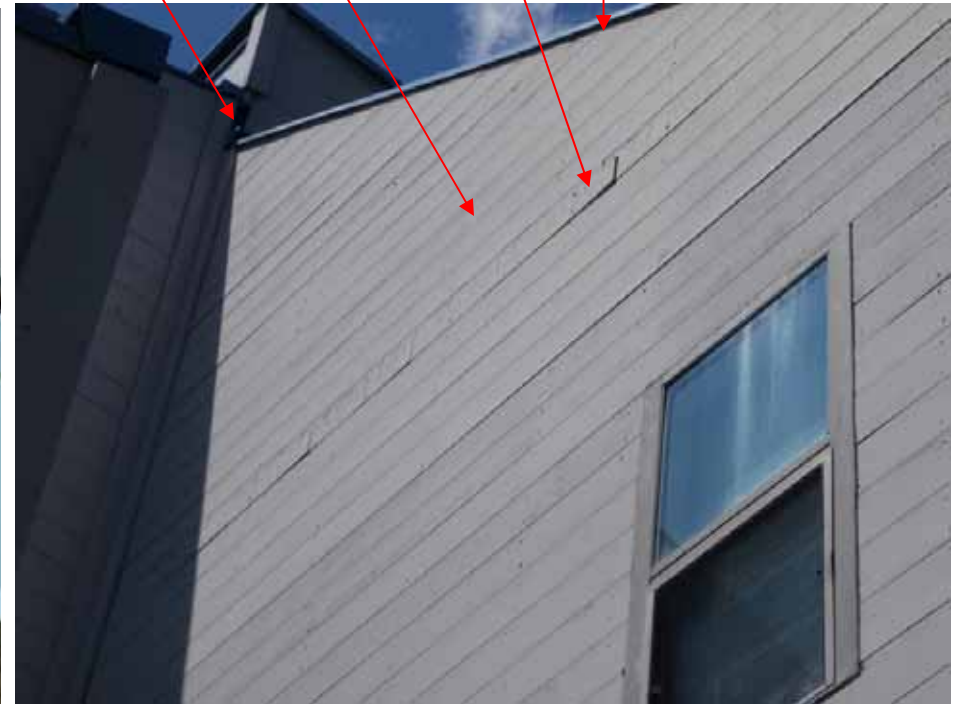
Exterior Visual Issues Throughout

Foundation Cap Flashing created negative drainage back into the Structure.

Open Areas in Siding Exposing Structure

Wood Siding pulling away from Substrate

Nails pulling away from Substrate

Cap Flashing throughout not overlapping siding or exposed gaps above siding

Inadequate Flashing at roof creating open area for Rain/Moisture Penetration

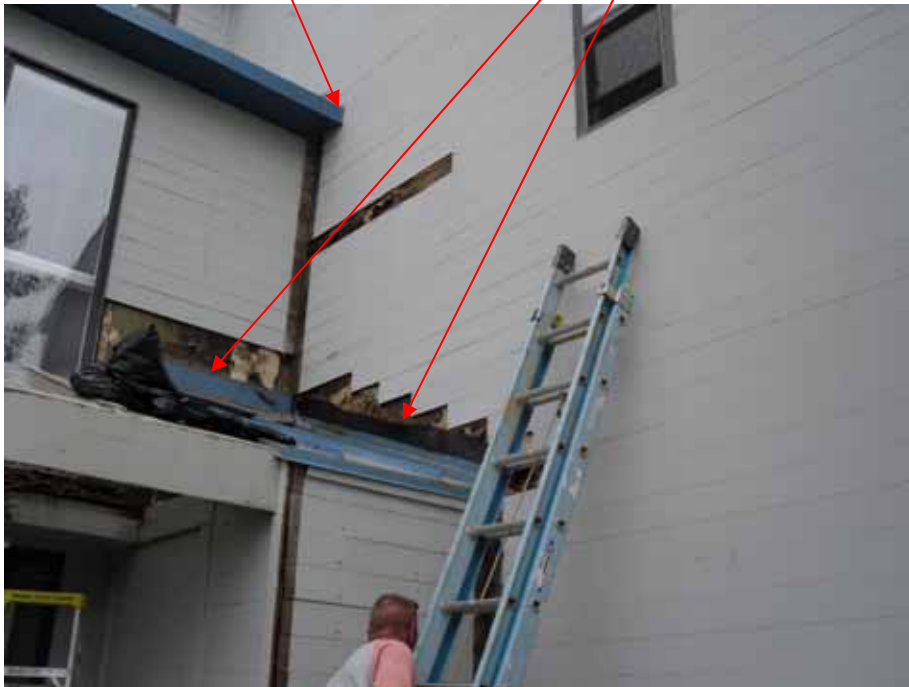
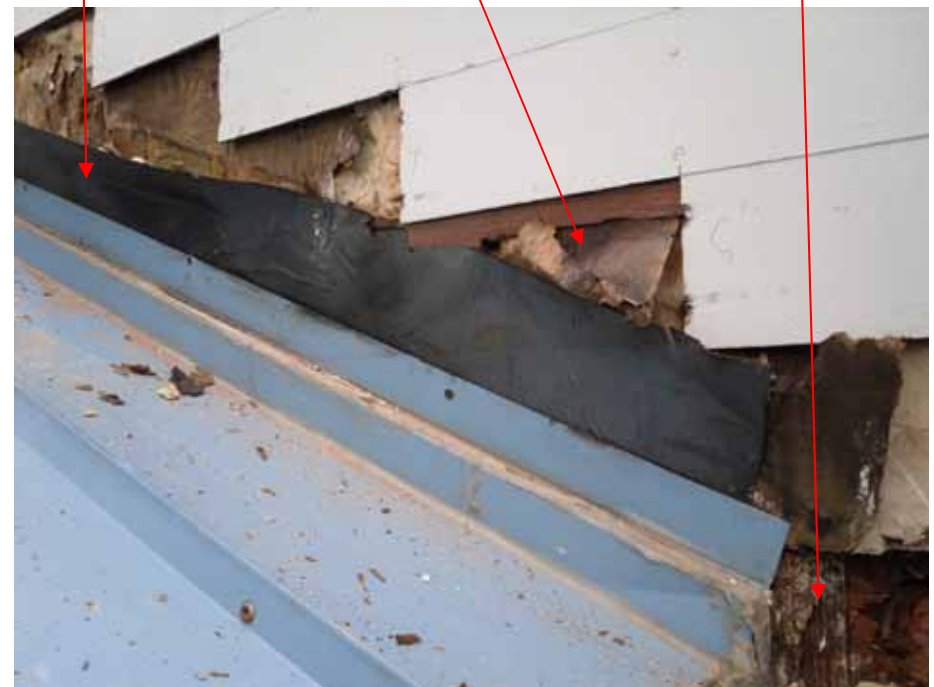
The Problem Starts at the Roof

Water Runs behind wood Siding
due to Inadequate Flashing

Water Wicks up behind Wood
Siding due to inadequate spacing
of Siding off Roof Surface,
Counter Flashing & Lack of Tar
Paper up the Wall

Tar Paper Underlayment only
runs up the Wall a few inches

Water Penetration occurs
above Tar Paper

Water then runs
behind Wood Siding

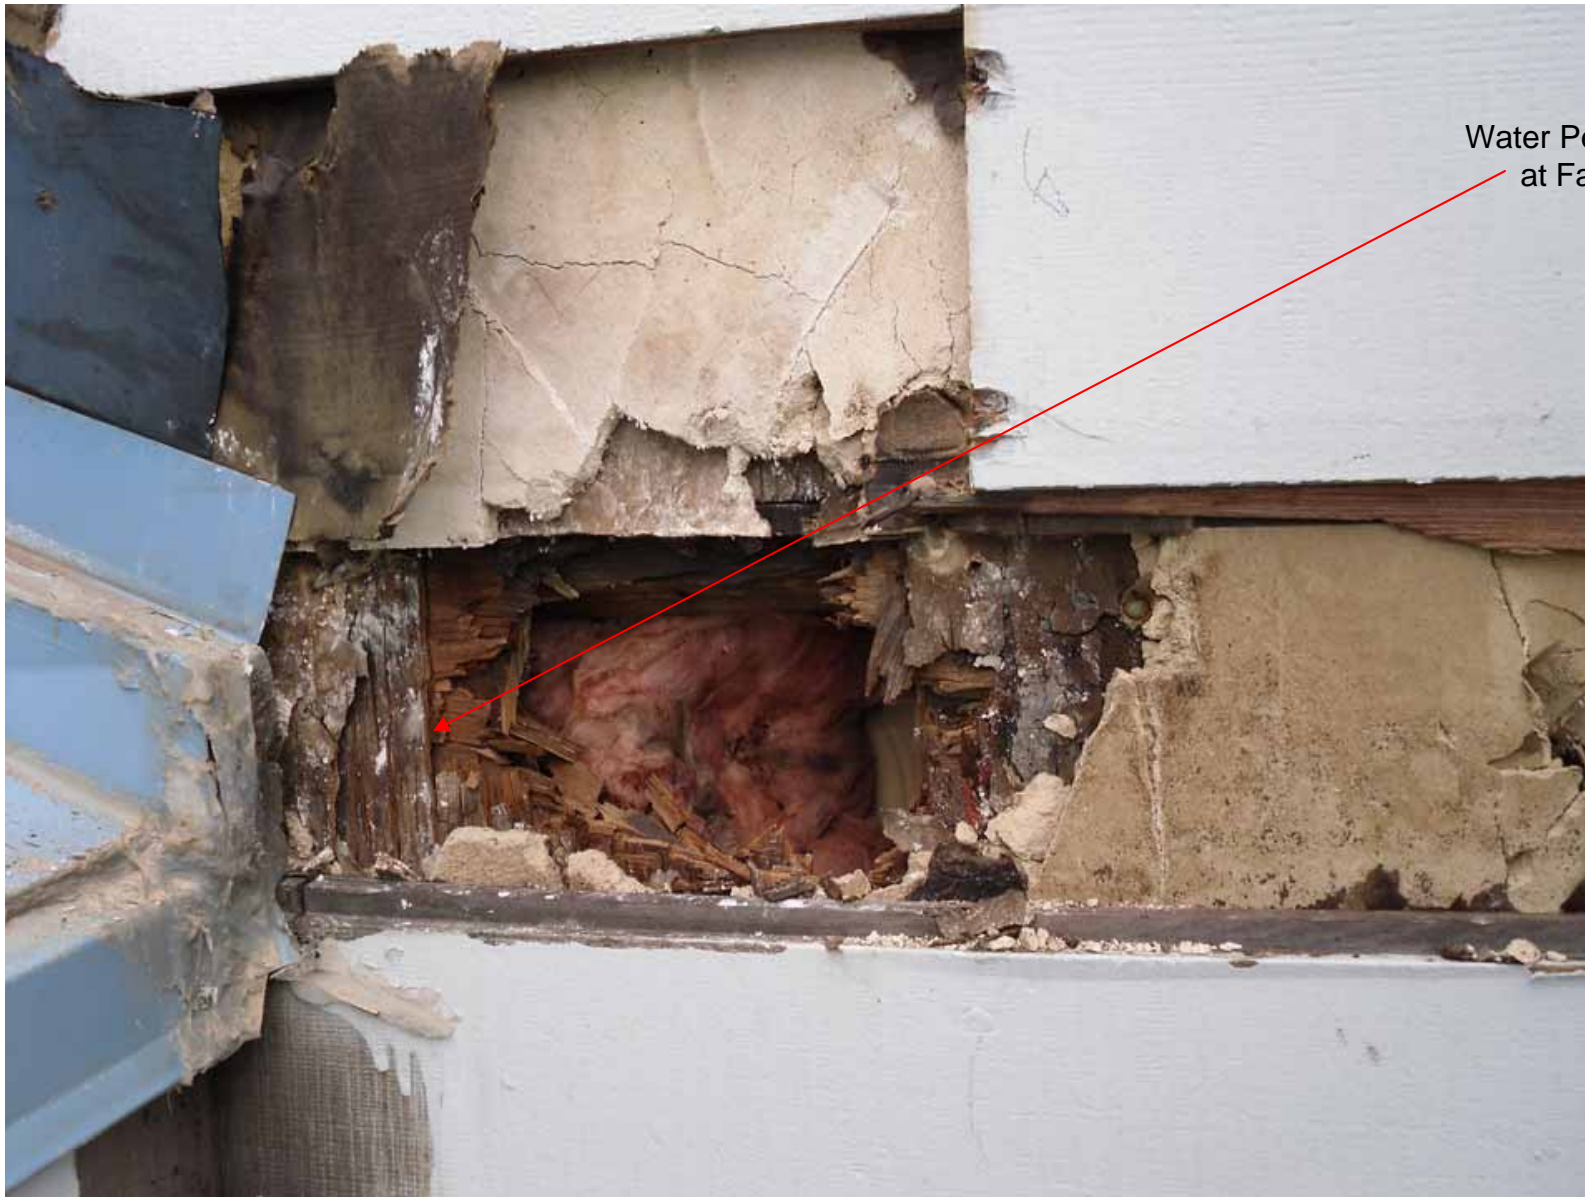
The Problem Starts at the Roof

Water Penetration Structure
at Fascia of Shed Roofs

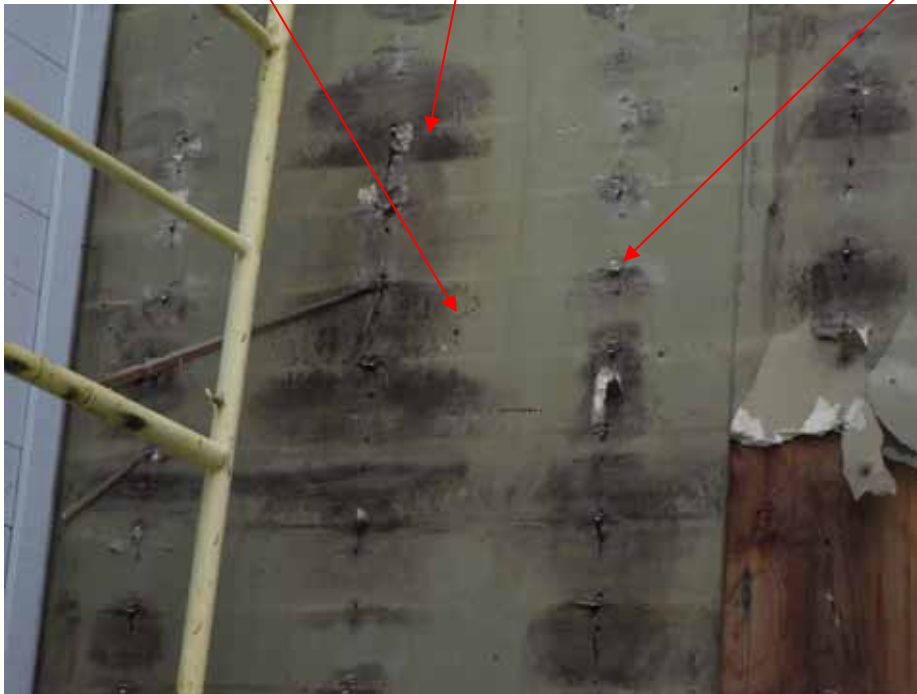
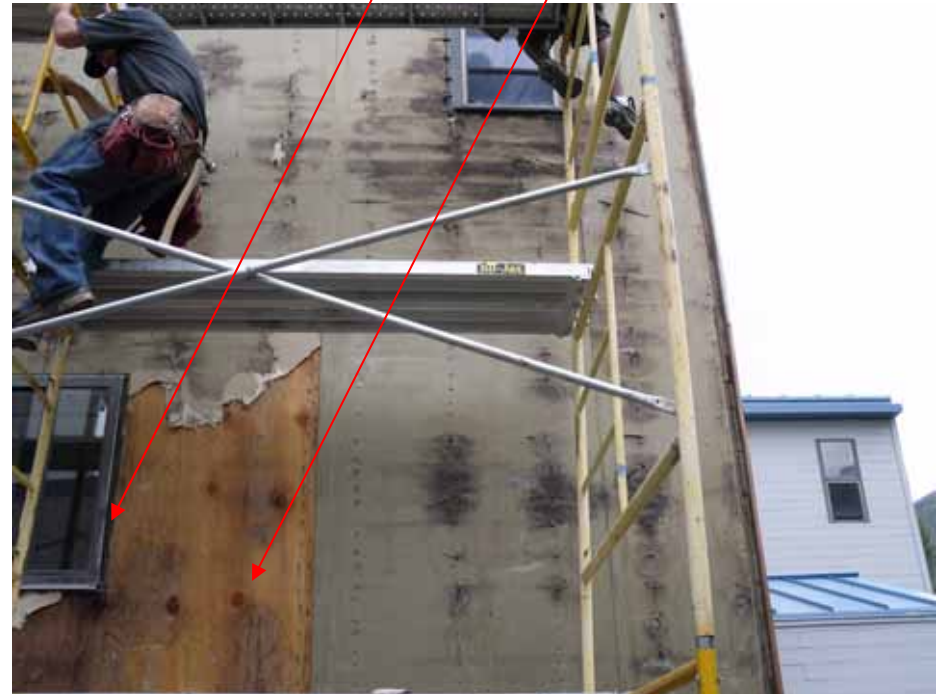
No Felt or Building Paper Installed

Moisture behind Wood Siding is immediately absorbed by the Exterior Drywall due to lack of Building Paper

Drywall Rots

Siding Nails Rot

No Flashing above Windows

Exterior Plywood Sheathing Rots

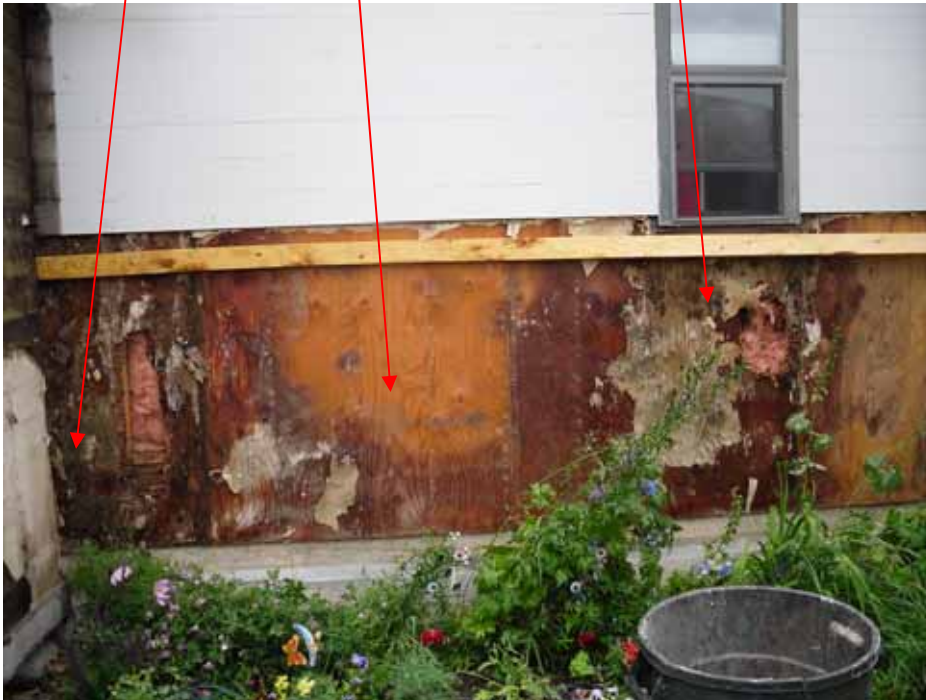
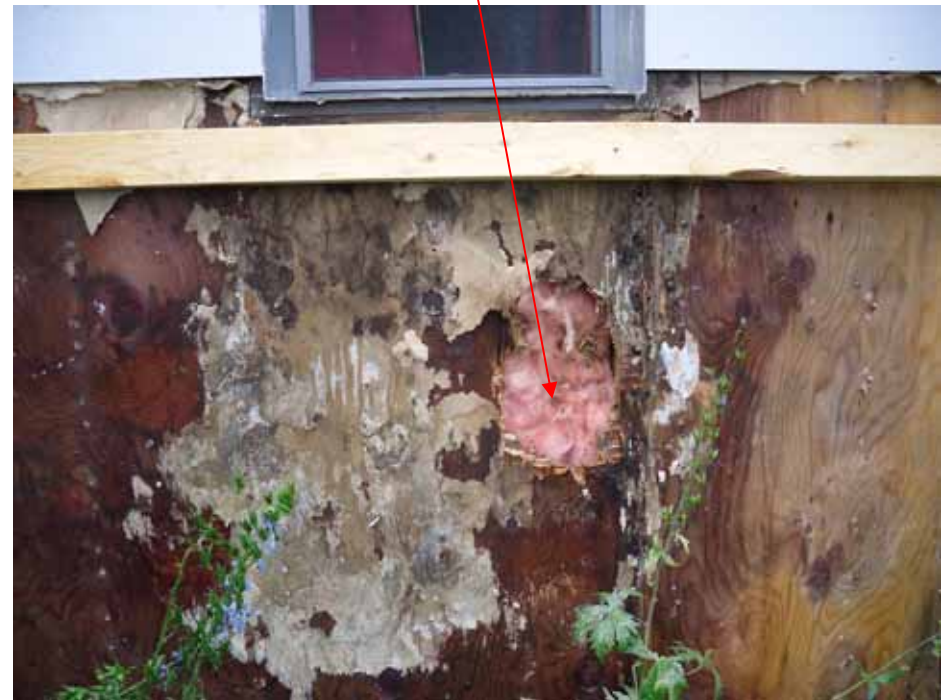
Water Works its Way Through

Rotting Exterior
Plywood Sheathing

Mold starts to occur

Water Penetrates
around Windows

Batt Insulation becomes
saturated, sags and loses R-
Value while holding Moisture

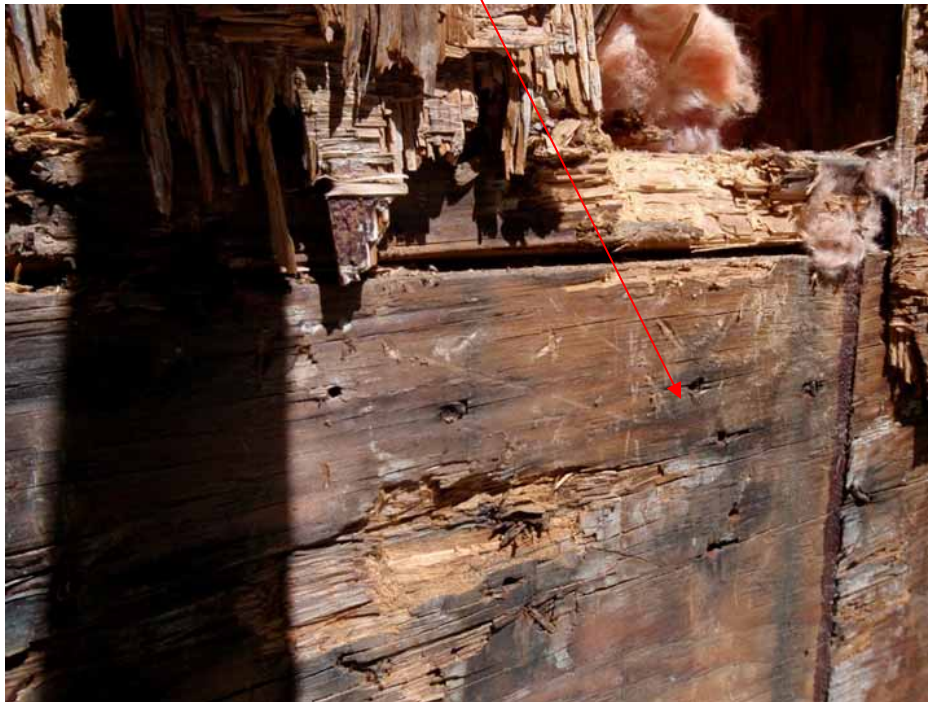
MAJOR Structural
Beams are rotten

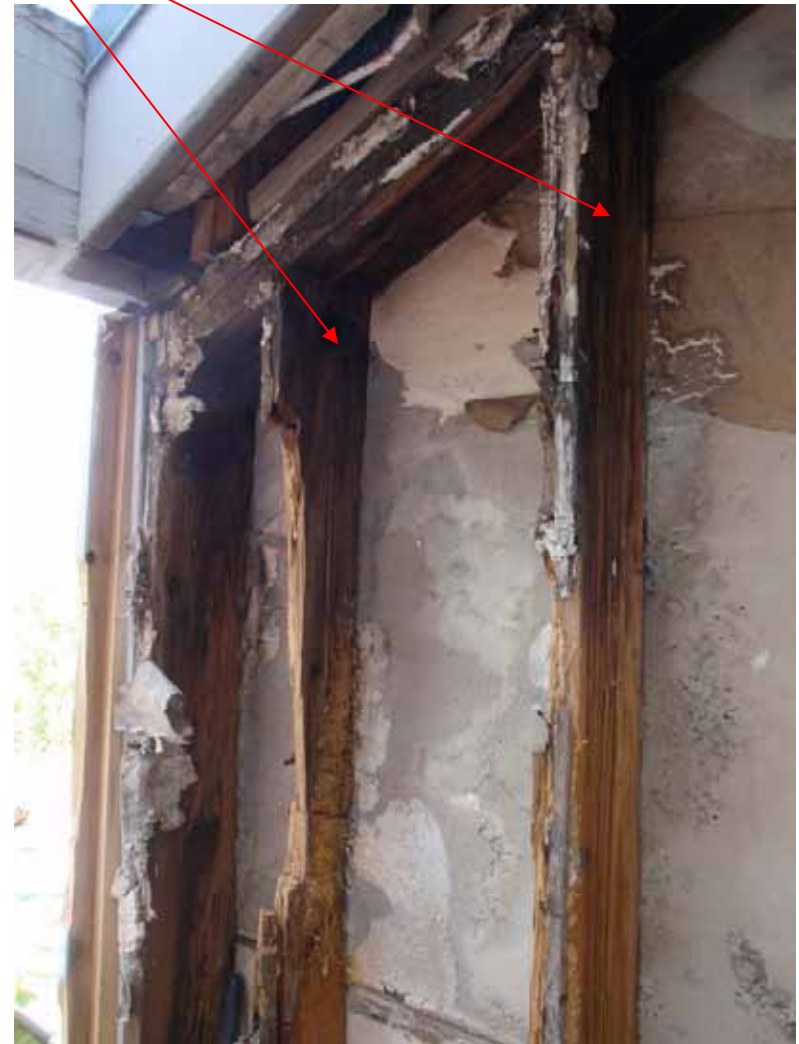
Structural Load Bearing
Studs are rotten

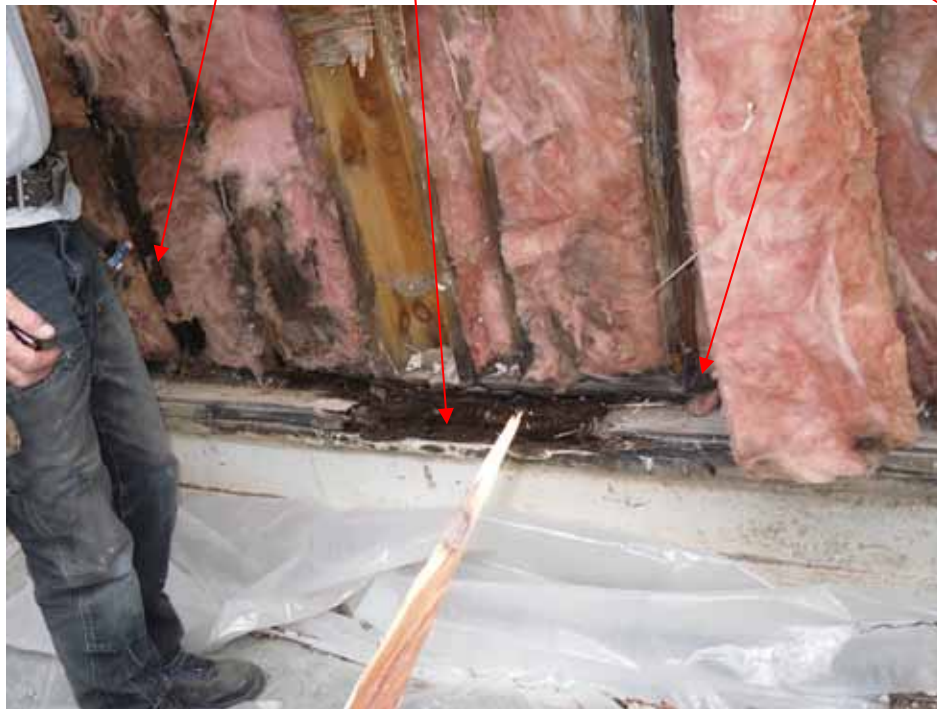
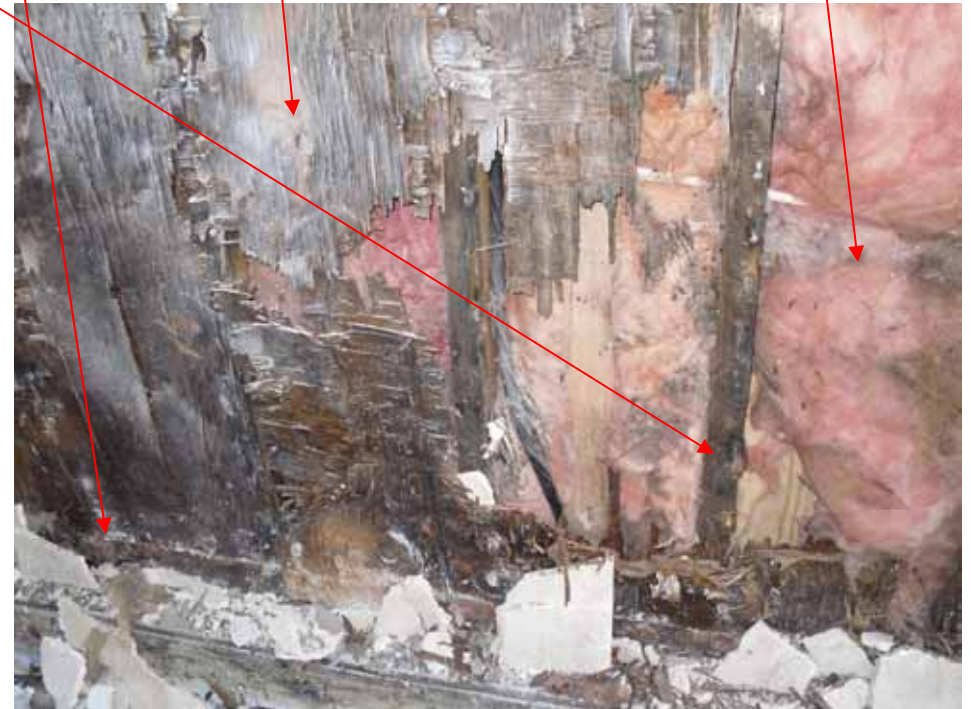
Moisture Wicks up Walls from Snow Stacked against Structure at Drop Zones

Structural Load Bearing
Studs are completely rotten

Mold

Wood Sill Plate on a
Structural Load Bearing
Wall is completely rotten

Plywood Sheathing is
completely rotten

Batt Insulation becomes
soaked with Moisture

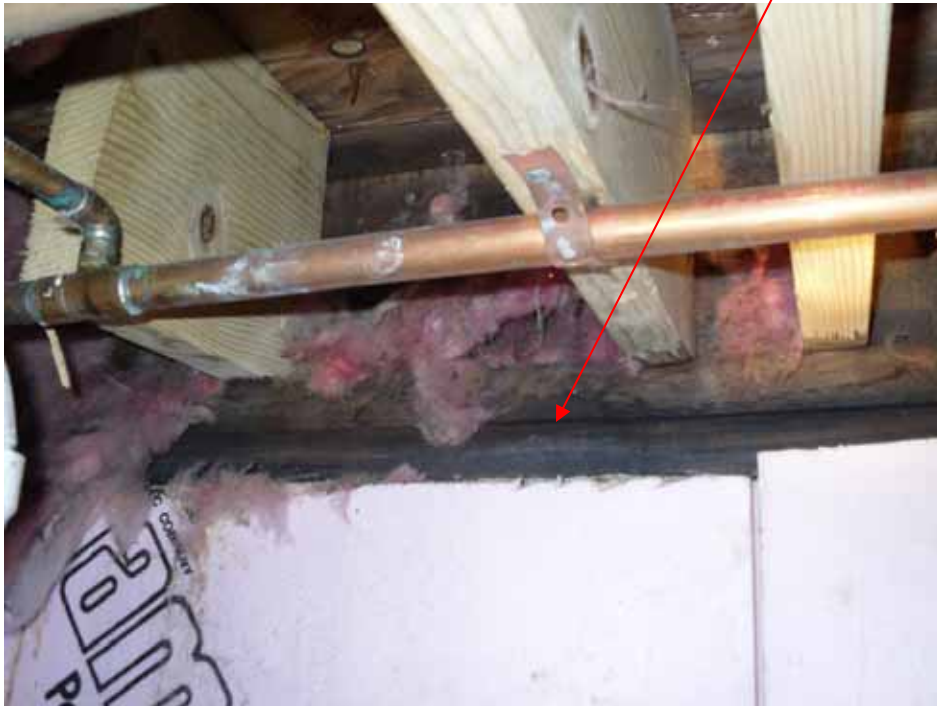
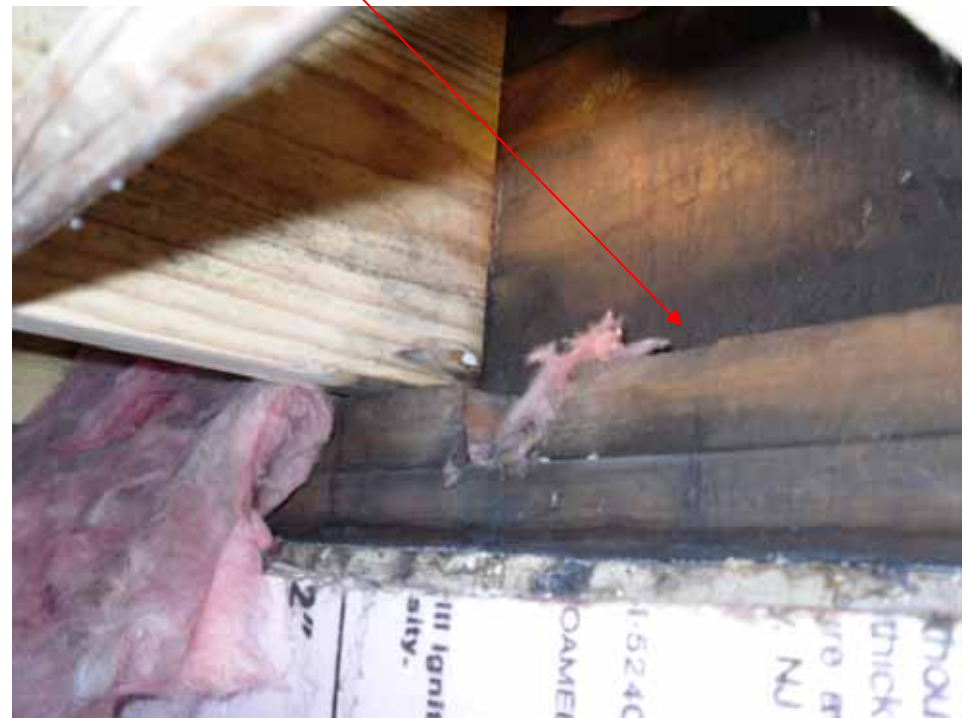
Mold
