# CENTENNIAL HOUSING PROJECT SURVEY AND ANALYSIS

**WHITE HORSE CONSULTANTS**  
**LAWRENCE A. DOBLE, P.E., C.B.O.**  
Box 3042, Aspen, CO 81612  
2061mfr@sopris.net  
970-920-2405

DRAFT (January 25, 1999)

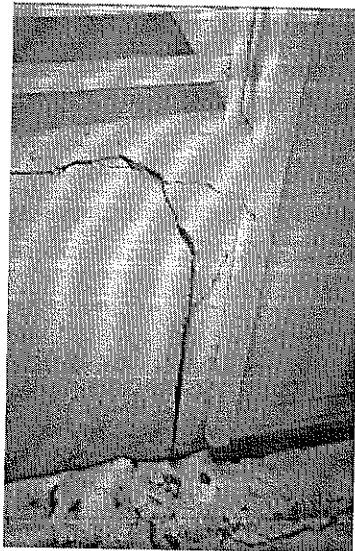
The most obvious sign of distress was a major crack in an exterior retaining wall system between units 214 & 215. There also was a portion of the floor that is deflected at an area (the common wall between units 214 & 217). There is a joist that has been cut resulting in the deflection. It appears that a plumber cut the floor joist during construction in order to run the waste pipes associated with the water closets.

*This is a photograph of the cracked exterior retaining wall between units 214 & 215.*

The exterior retaining wall should be rebuilt. The simplest abatement solution for floor deflection at the cut floor joist would be to provide a header (one 2x12 would be adequate) that would effectively "box out" the waste pipe. A licensed contractor should replace the exterior retaining wall. A licensed contractor should repair the floor joist. A licensed contractor should make other repairs, if discovered, during the exterior retaining wall and joist repairs.

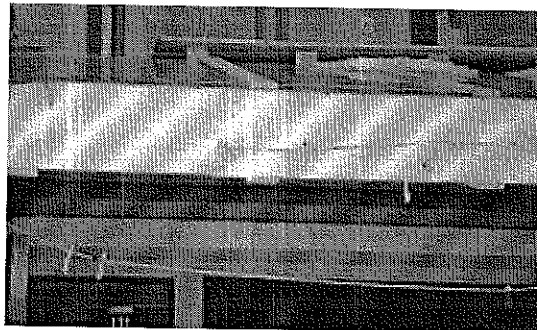
One visible sign of distress was the deflection of the exterior decks between units 314 & 316 and 317 & 319. It is not immediately obvious what caused the deflection of the exterior deck framing. There is a deck roof framing element at unit ? that has been damaged. It appears that the damage to the deck roof-framing element is the result of sliding snow and ice from above.

*This is a photograph of the cracked exterior deck roof beam at unit ?.*

An easy solution to the deflection of the exterior decks between units would be to prop them up with a footing placed at the outside end of each cantilevered beam. The solution to the damaged deck roof-framing element involves some form of protection from sliding snow and ice. The homeowners association should evaluate any potential solutions to the problem of sliding snow and ice with regard to architecture, etc. A licensed contractor should repair the exterior deck framing. A licensed contractor should make other repairs, if discovered, during the repair.

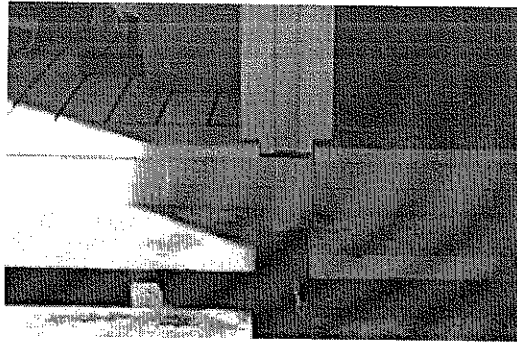
*This is a photograph of the exterior deck deflection between units 314 & 316 ?.*
