**Centennial Owner's Association**  
**100 - 400 Free Silver Ct. & 200 - 400 Teal Ct.**  
**Aspen, CO 81612**

**Level 1 Reserve Analysis**

**Report Period – 01/01/13 – 12/31/13**

**Date of Property Observation - June 25, 2012**  
**Project Manager - Matthew Woytek**  
**Main Contact Person - Mr. Russell Shaffran, Board of Directors**

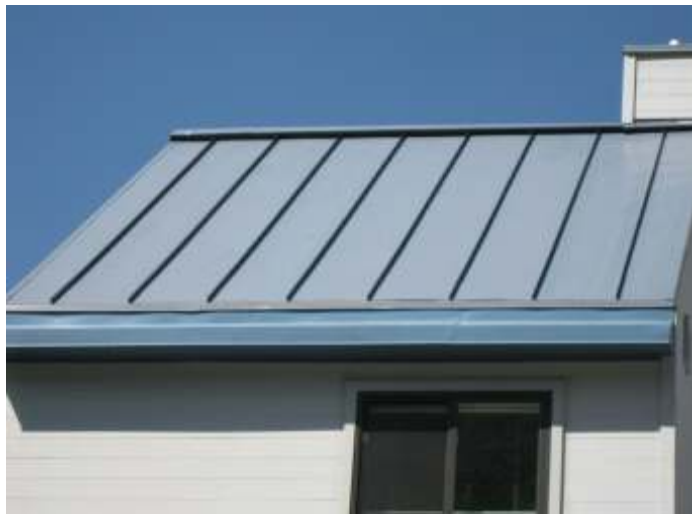
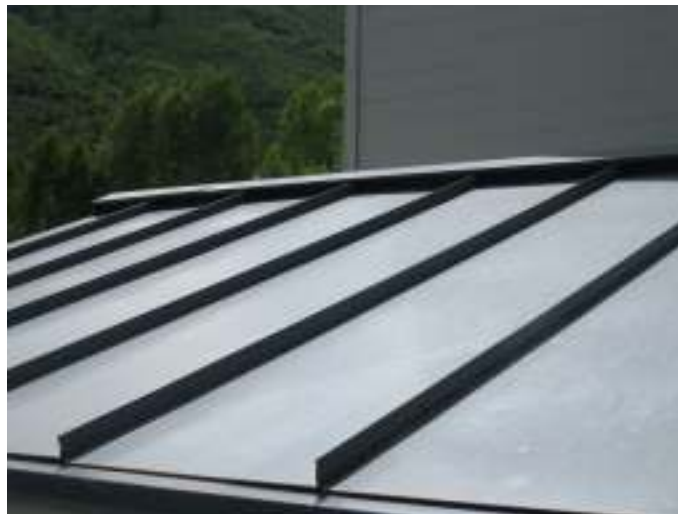
Comp #: 108 Standing Seam Metal Roof - Replace

Metal roofs appeared in fair to poor condition at time of observation with reported problems of possible water intrusion issues. Roofs should be replaced within the next 3 - 5 years in order to ensure proper function of unit building roofs. Expect to replace metal roofs every 30 - 35 years.

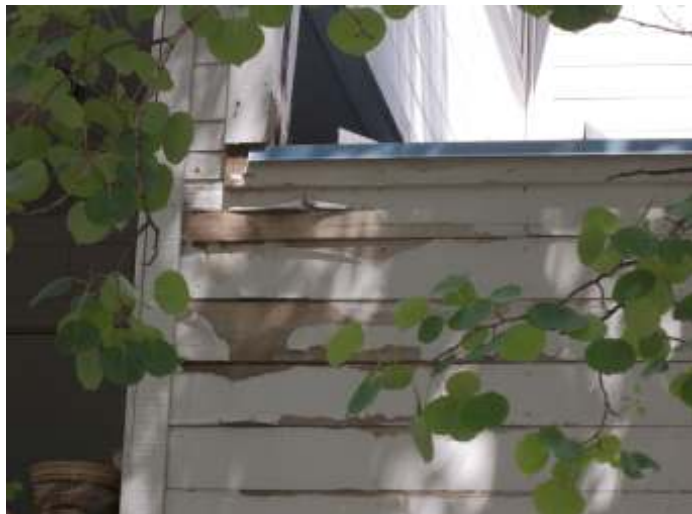
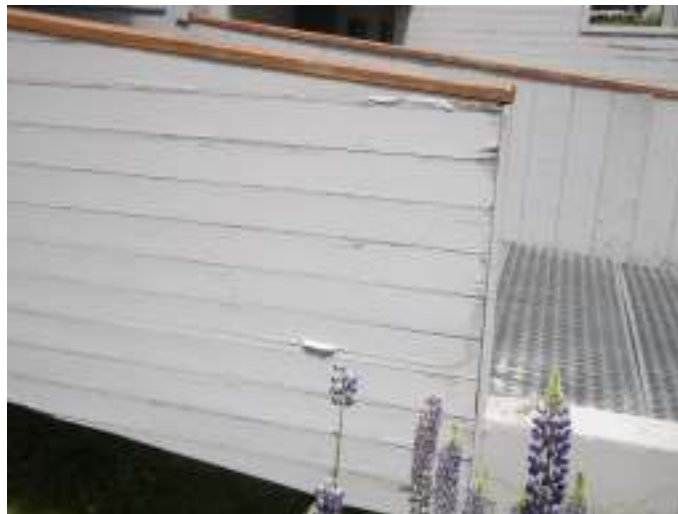
Comp #: 204 Building Ext Surfaces - Repaint

Paint was peeling and in poor condition in numerous areas throughout the community. We are recommending the association begins replacing the siding on the unit buildings starting in 2013. Begin painting the buildings after the siding project is complete. Local professionals recommend repainting hardboard siding every 5 years in order to maintain appearances and to protect the building exterior surfaces.

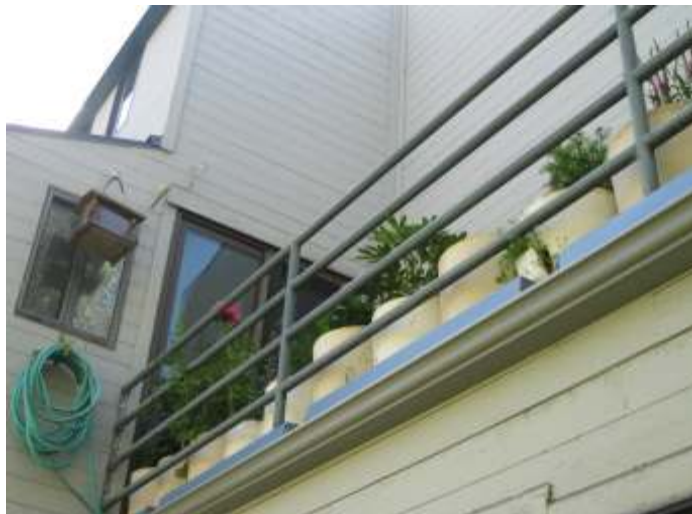
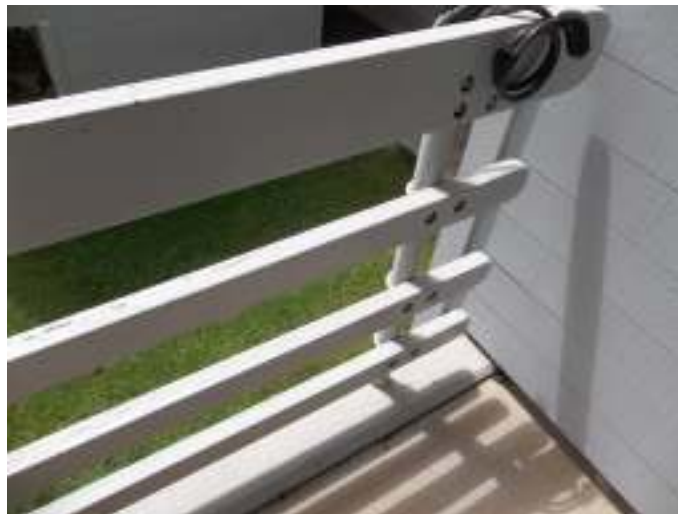
Comp #: 207 Railings - Repaint

Metal rails throughout the community had thin, faded paint or no paint at all at time of observation. Majority of wood rails are either partially or fully protected from the elements and appeared in better condition. It is recommended by local contractors that exterior railing be painted every 3 - 4 years in order to maximize the useful life of the rail. It is vitally important that exterior railing components remain protected from precipitation. Based on the observed conditions, we recommend painting all rails this fiscal year (2013).

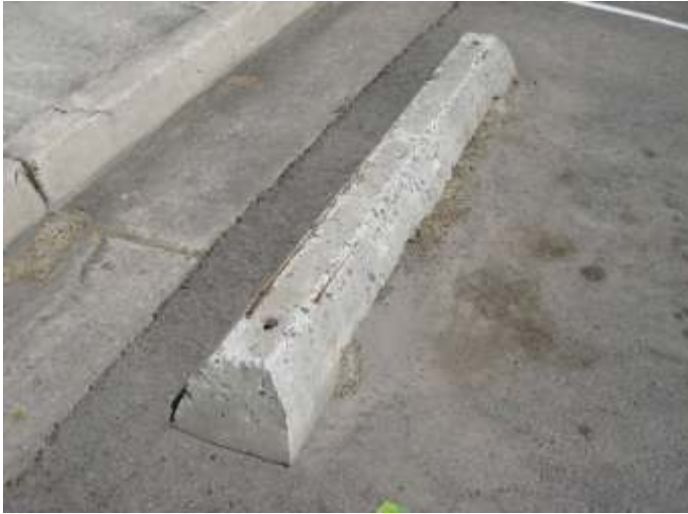
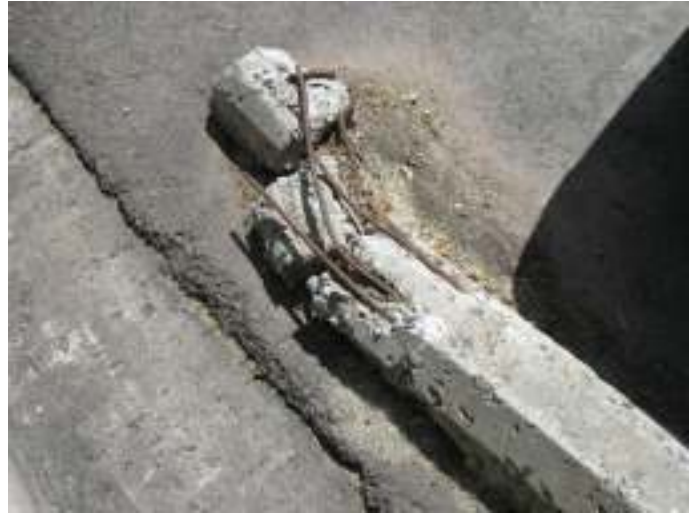
Comp #: 214 Parking Stops - Replace

Parking stops appeared in poor condition at time of observation with cracked, spalled and deteriorated concrete apparent. We recommend replacing parking stops every 15 years in order to ensure safety and maintain appearances of the community.

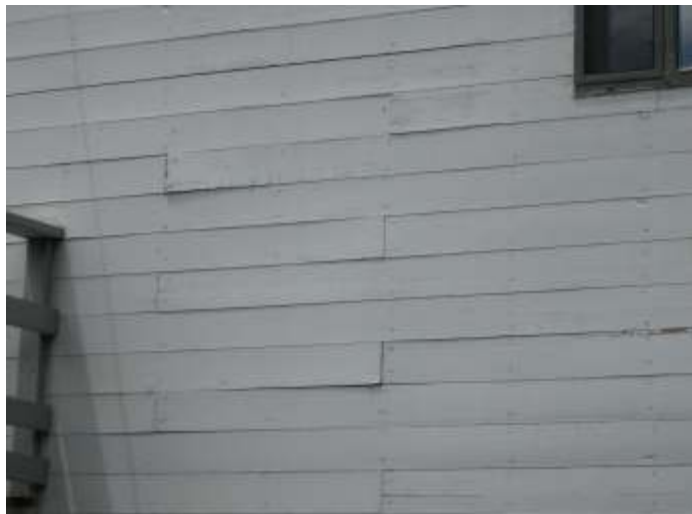
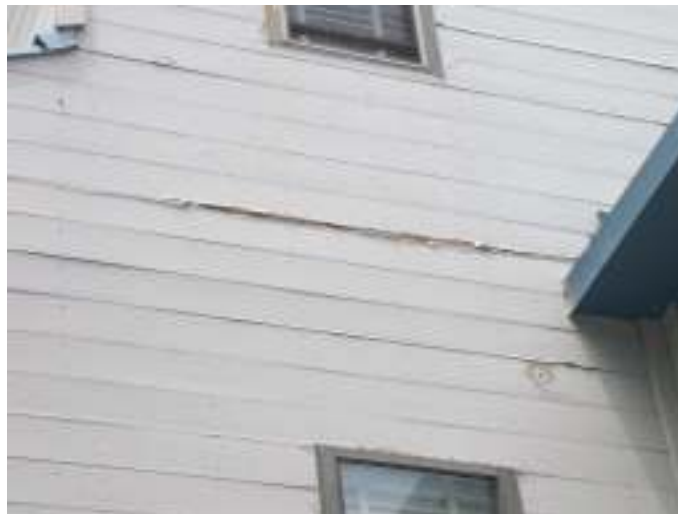
Comp #: 305 Wood Siding - Replace

It was reported that the association is going through water mitigation projects and it was apparent in areas that there has been some intrusive inspections performed recently. Due to the potential problems associated with the siding, we recommend reserving to completely replace all siding as soon as possible. Plan to replace all siding starting in 2013.

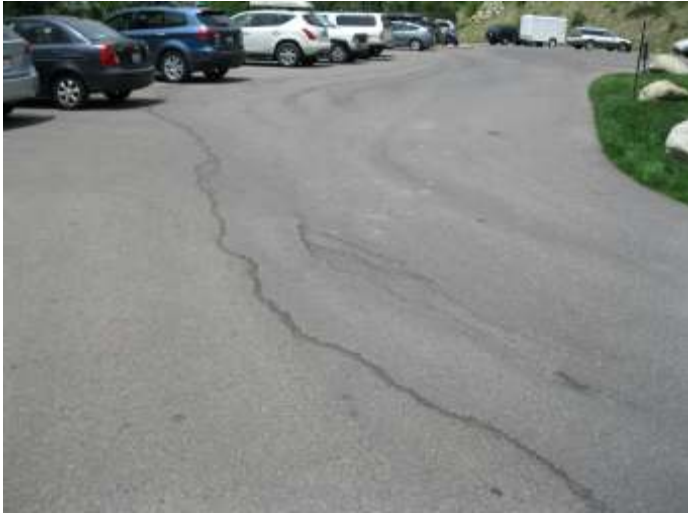
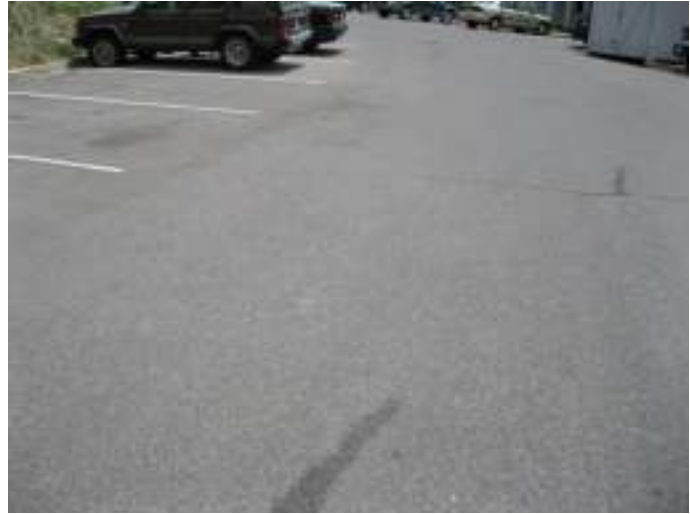
Comp #: 401 Asphalt - Overlay

Surfaces are dry and are in need of a seal coat this next year. Depending on traffic, maintenance levels, and snow removal techniques (plow, sand, snow melt, etc.), the life of asphalt should range between 15 - 20 years.

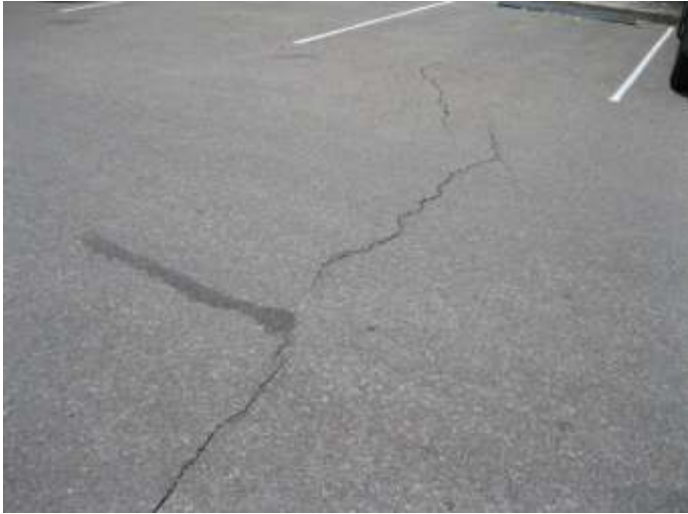
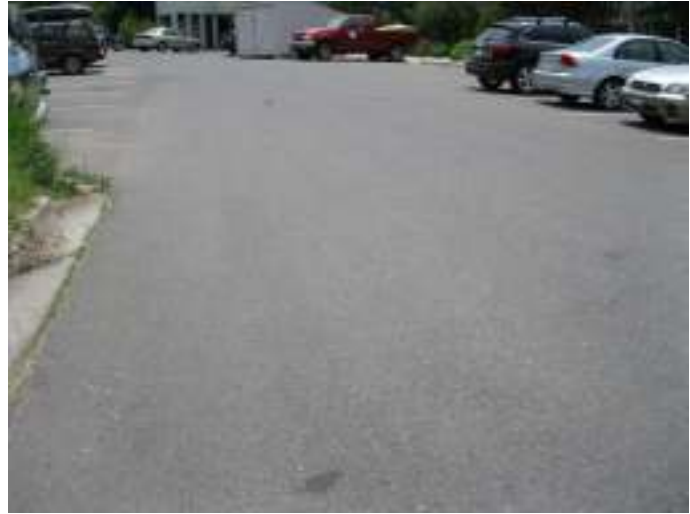
Comp #: 402 Asphalt - Seal Coat/crack fill

In this climate, seal coating is recommended every 3 - 4 years. In between seal cycles, asphalt should be crack filled and repaired as a preventative maintenance measure to ensure maximum life expectancy from the material.

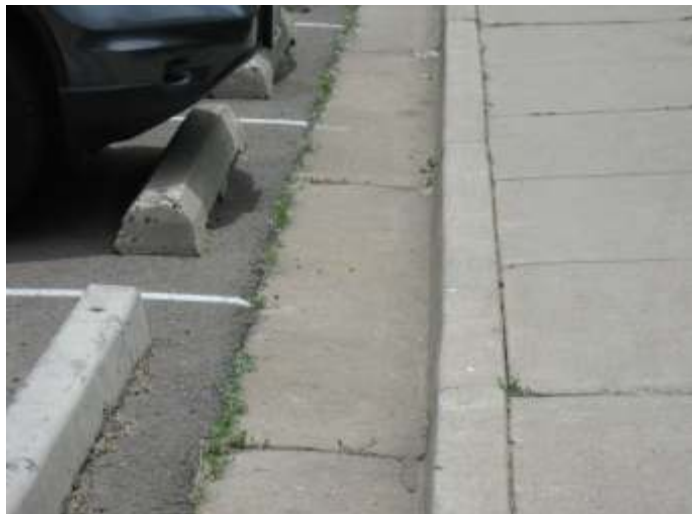
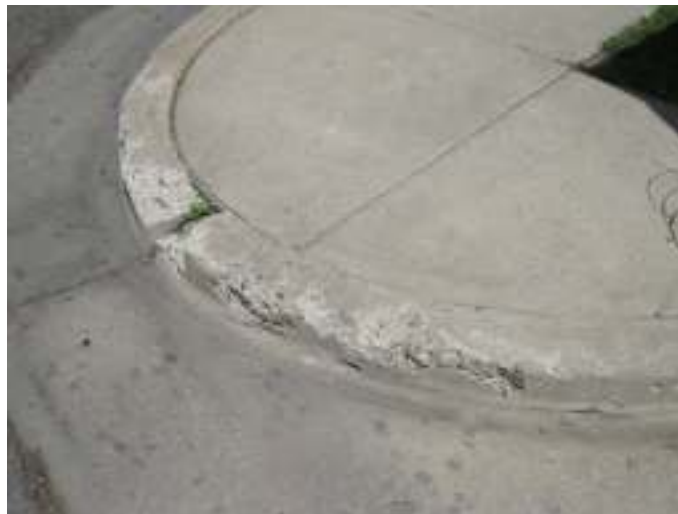
Comp #: 407 Curb and Gutters - Repair

At the time of the observation, there were only minor signs of cracking or other problems. Since it is unlikely that all surfaces will need to be replaced at the same time, we suggest establishing a Reserve fund to repair 10% of the area (370 GSF) every 4 years. Coordinate future repairs with asphalt work for best cost estimate since most asphalt companies can also perform concrete repairs.

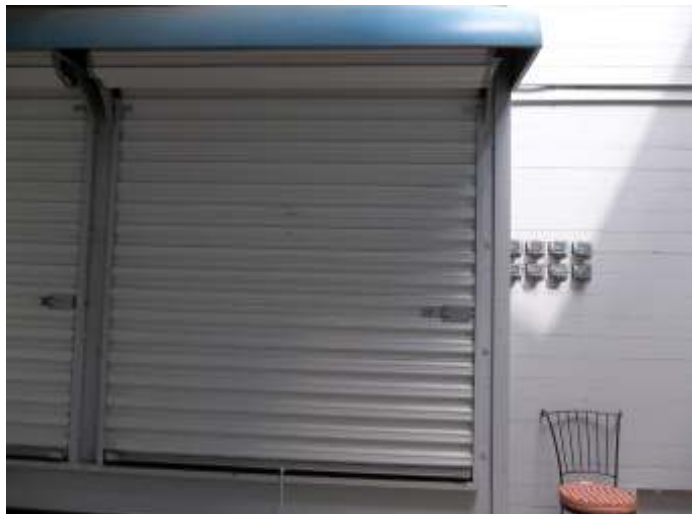
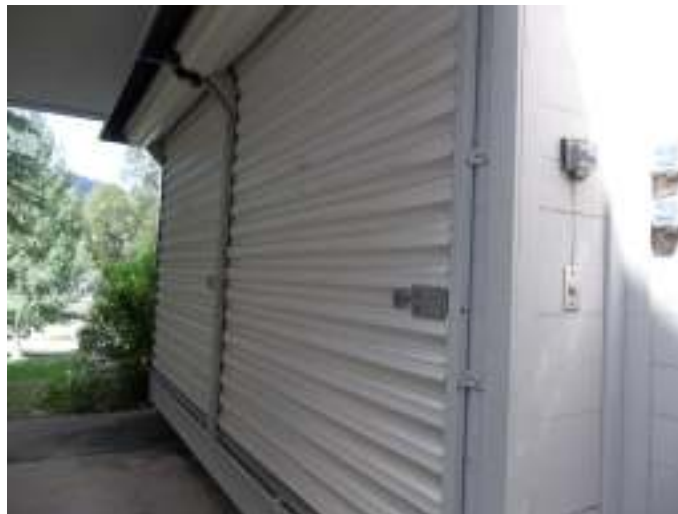
Comp #: 502 Rollup Doors - Replace

All rollup doors worked properly at time of observation with no overt problems noted. These types of doors have a long useful life and due to the limited amount of use, we expect these doors to last approximately 30 years. Make minor repairs as needed while reserving to replace doors every 35 years.

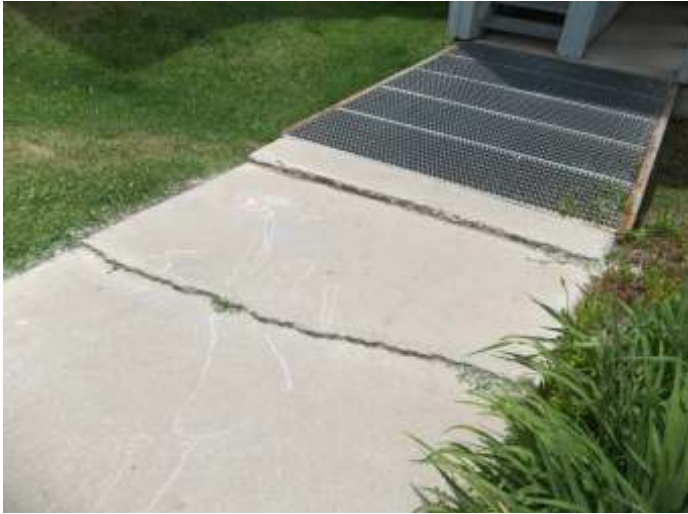
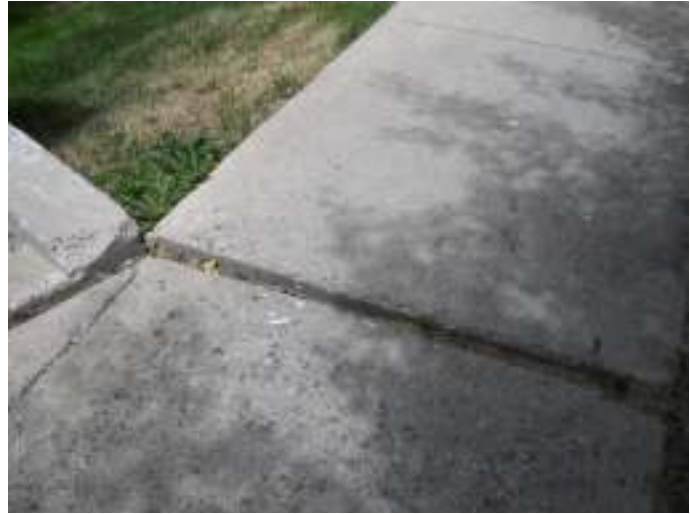
Comp #: 601 Concrete Sidewalks/Decks - Repair

Signs of settling, advanced spalling, cracking and deteriorating concrete was apparent at time of observation. However, much of the concrete on this line item is partially or fully protected from precipitation which will allow for a longer useful life. Similar to other concrete components in this report, it is unlikely that all concrete surfaces will fail and need to be replaced at the same time, frequent repairs and replacement to a percentage of the area (10% or 2520 GSF), should be anticipated every 4 years.

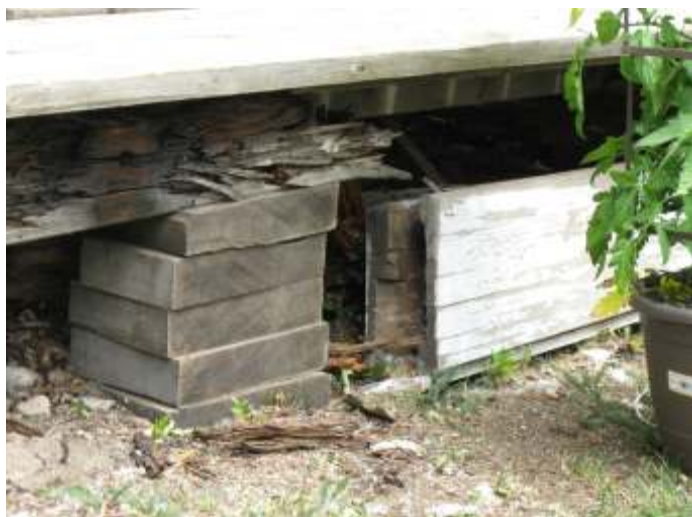
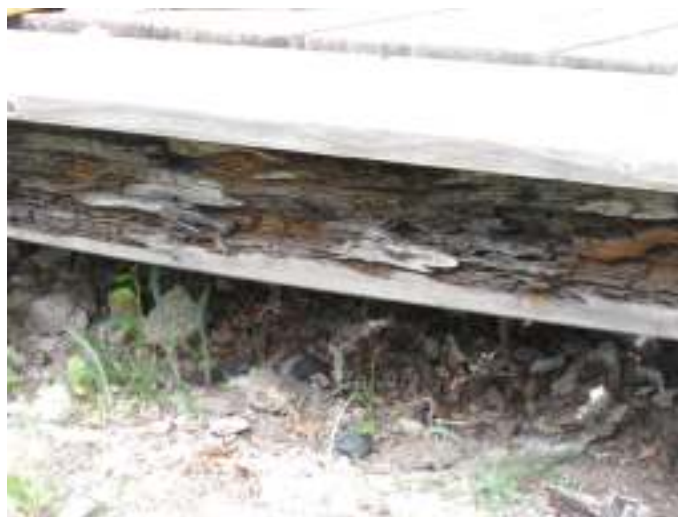
Comp #: 602 Lower Rear Decks - Replace (Phase 1)

Rear decks were in very poor condition at time of observation with completely rotted fascia, make-shift support and dangerous walking surfaces apparent. The community is currently prioritizing the repairs to rear decks and expect to make repairs annually until all decks are deemed safe and acceptable conditions for walking surfaces is achieved. In the future, expect to replace decking every 18 - 20 years in order to avoid a recurrence of observed conditions.

NOTE: Reported that the association has been in the process of prioritizing replacement of the rear decks. The association, reportedly, was constructed on mine tailings and this has led to EPA restrictions in digging piers to properly support the decks. If more information regarding the EPA situation, costs of the decks, or total number of decks to be replaced in the near future is decided on, we can adjust our recommendations upon revising this draft report.

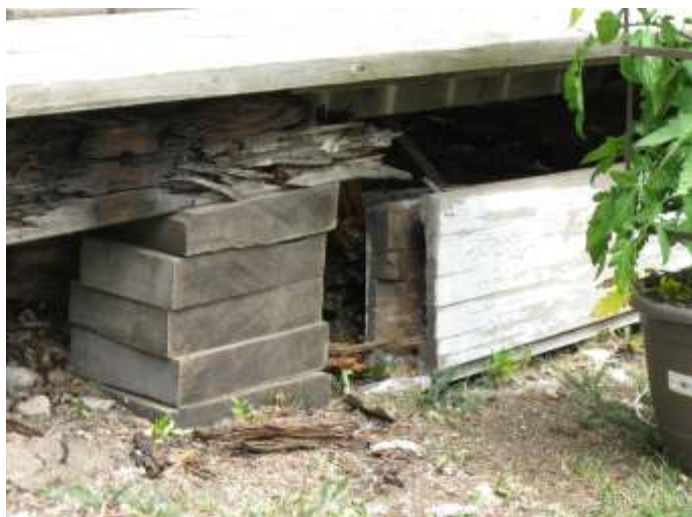
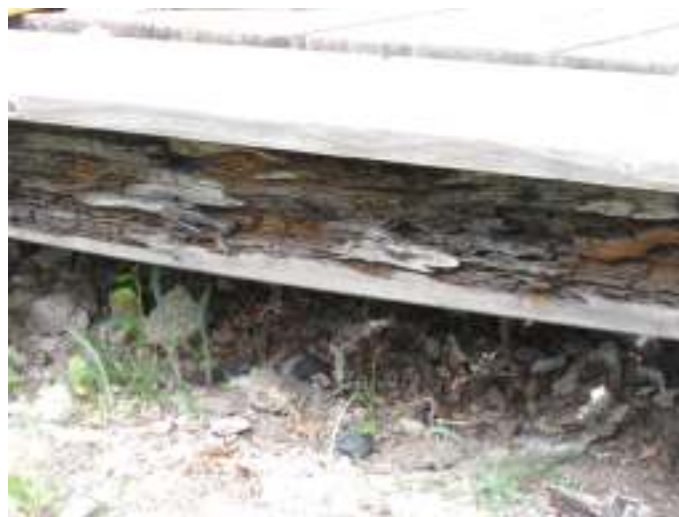
Comp #: 603 Lower Rear Decks - Replace (Phase 2)

Rear decks were in very poor condition at time of observation with completely rotted fascia, make-shift support and dangerous walking surfaces apparent. The community is currently prioritizing the repairs to rear decks and expect to make repairs annually until all decks are deemed safe and acceptable conditions for walking surfaces is achieved. In the future, expect to replace decking every 18 - 20 years in order to avoid a recurrence of observed conditions.

NOTE: Reported that the association has been in the process of prioritizing replacement of the rear decks. The association, reportedly, was constructed on mine tailings and this has led to EPA restrictions in digging piers to properly support the decks. If more information regarding the EPA situation, costs of the decks, or total number of decks to be replaced in the near future is decided on, we can adjust our recommendations upon revising this draft report.

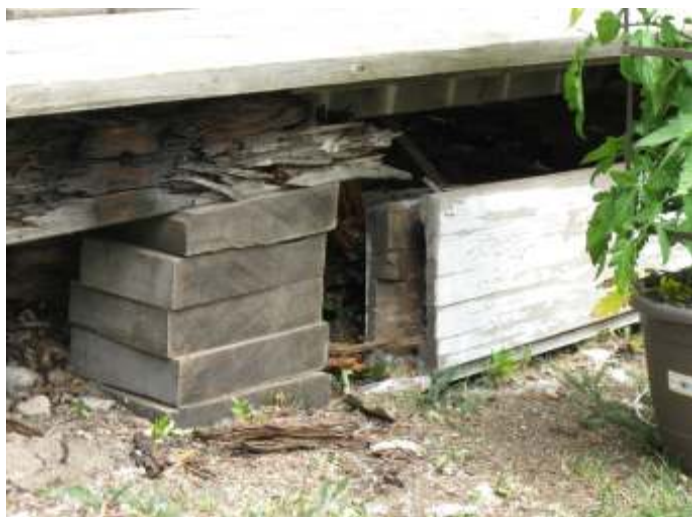
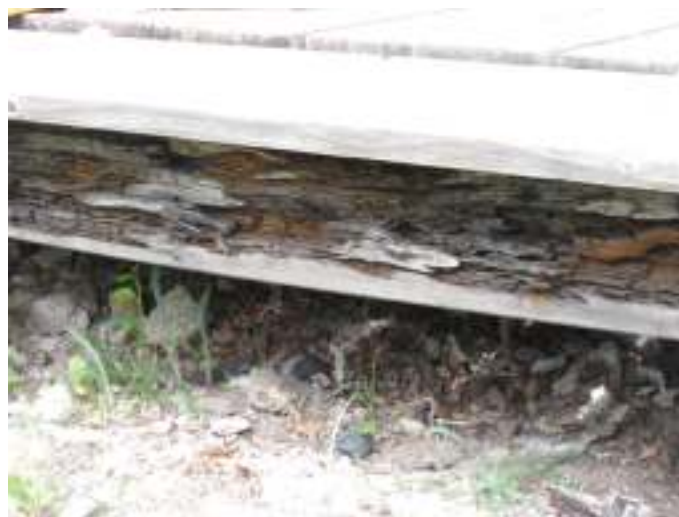
Comp #: 604 Lower Rear Decks - Replace (Phase 3)

Rear decks were in very poor condition at time of observation with completely rotted fascia, make-shift support and dangerous walking surfaces apparent. The community is currently prioritizing the repairs to rear decks and expect to make repairs annually until all decks are deemed safe and acceptable conditions for walking surfaces is achieved. In the future, expect to replace decking every 18 - 20 years in order to avoid a recurrence of observed conditions.

NOTE: Reported that the association has been in the process of prioritizing replacement of the rear decks. The association, reportedly, was constructed on mine tailings and this has led to EPA restrictions in digging piers to properly support the decks. If more information regarding the EPA situation, costs of the decks, or total number of decks to be replaced in the near future is decided on, we can adjust our recommendations upon revising this draft report.

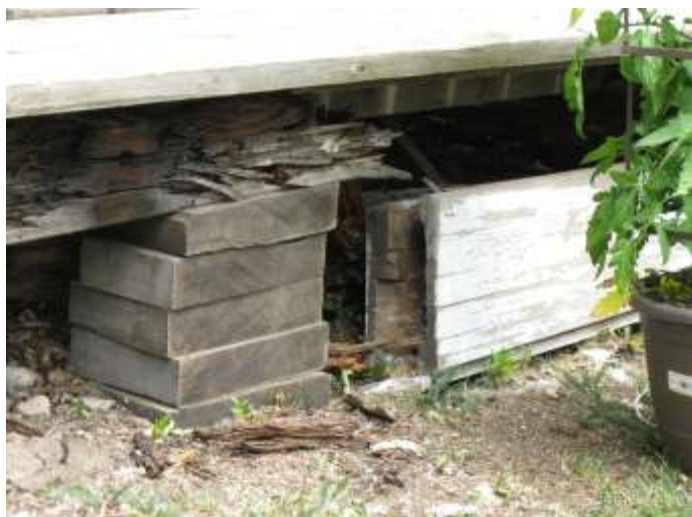
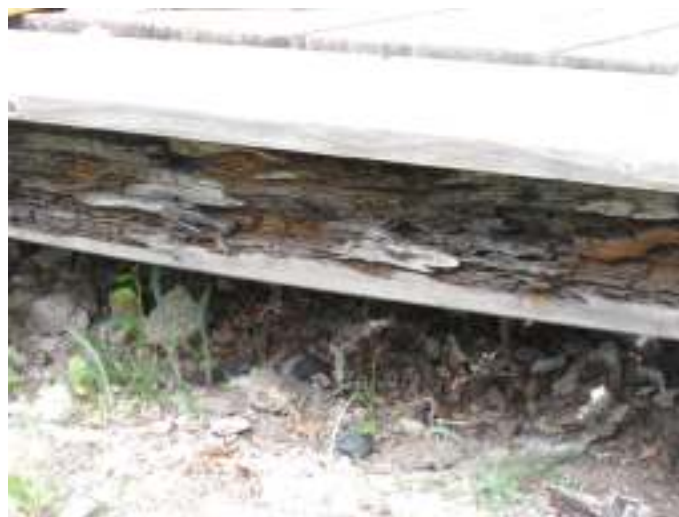
Comp #: 605 Lower Rear Decks - Replace (Phase 4)

Rear decks were in very poor condition at time of observation with completely rotted fascia, make-shift support and dangerous walking surfaces apparent. The community is currently prioritizing the repairs to rear decks and expect to make repairs annually until all decks are deemed safe and acceptable conditions for walking surfaces is achieved. In the future, expect to replace decking every 18 - 20 years in order to avoid a recurrence of observed conditions.

NOTE: Reported that the association has been in the process of prioritizing replacement of the rear decks. The association, reportedly, was constructed on mine tailings and this has led to EPA restrictions in digging piers to properly support the decks. If more information regarding the EPA situation, costs of the decks, or total number of decks to be replaced in the near future is decided on, we can adjust our recommendations upon revising this draft report.

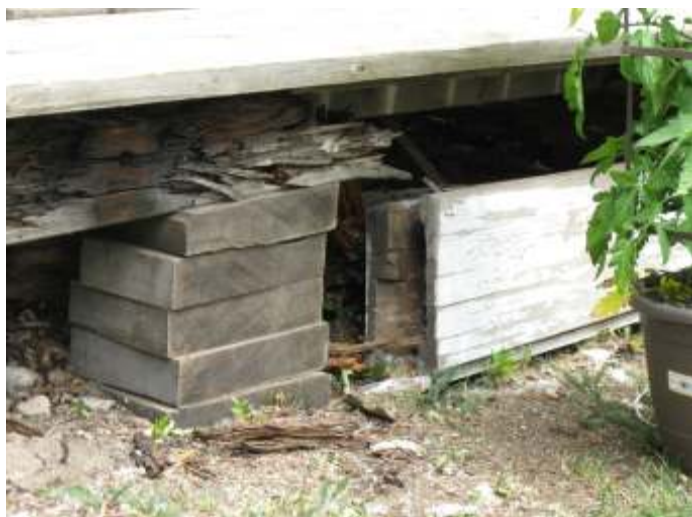
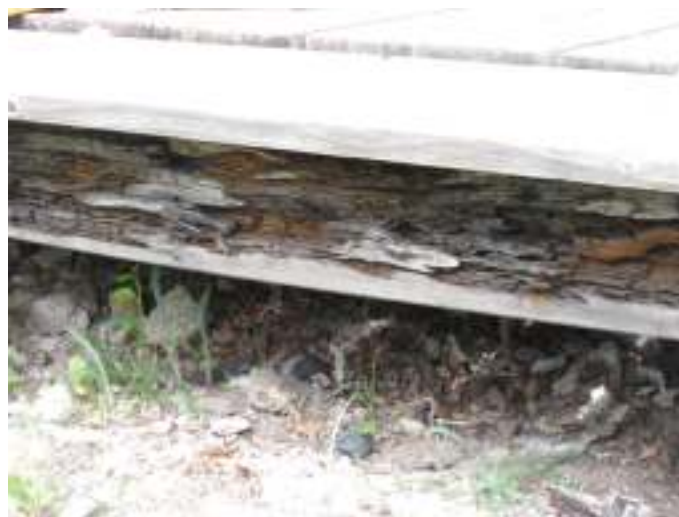
Comp #: 606 Lower Rear Decks - Replace (Phase 5)

Rear decks were in very poor condition at time of observation with completely rotted fascia, make-shift support and dangerous walking surfaces apparent. The community is currently prioritizing the repairs to rear decks and expect to make repairs annually until all decks are deemed safe and acceptable conditions for walking surfaces is achieved. In the future, expect to replace decking every 18 - 20 years in order to avoid a recurrence of observed conditions.

NOTE: Reported that the association has been in the process of prioritizing replacement of the rear decks. The association, reportedly, was constructed on mine tailings and this has led to EPA restrictions in digging piers to properly support the decks. If more information regarding the EPA situation, costs of the decks, or total number of decks to be replaced in the near future is decided on, we can adjust our recommendations upon revising this draft report.

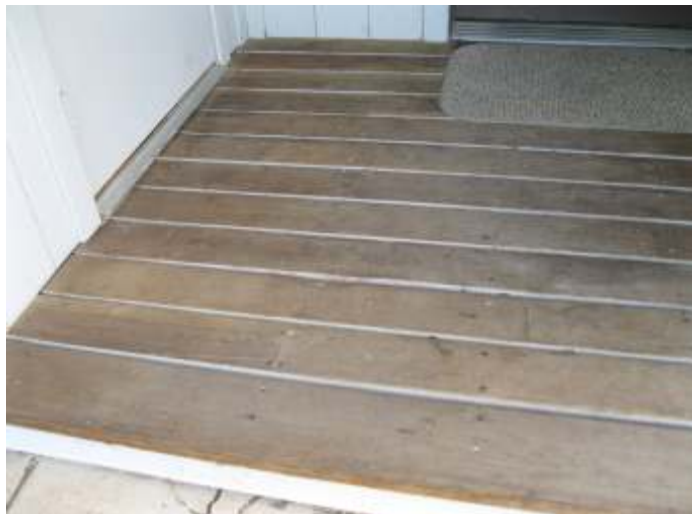
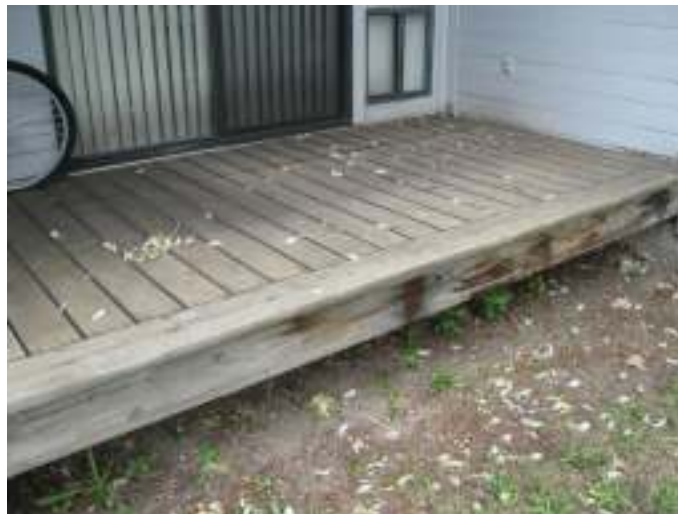
Comp #: 608 Community Decking - Reseal

All decking throughout the community appeared dry with very little, if any, stain/sealant on the surface. These decks are in need of resealing this fiscal year in order to restore appearances and ensure a safe walking surface for the residents. Expect to reseal wood decking every 3 years in order to protect the wood from advanced deterioration, and in order to maximize useful life.

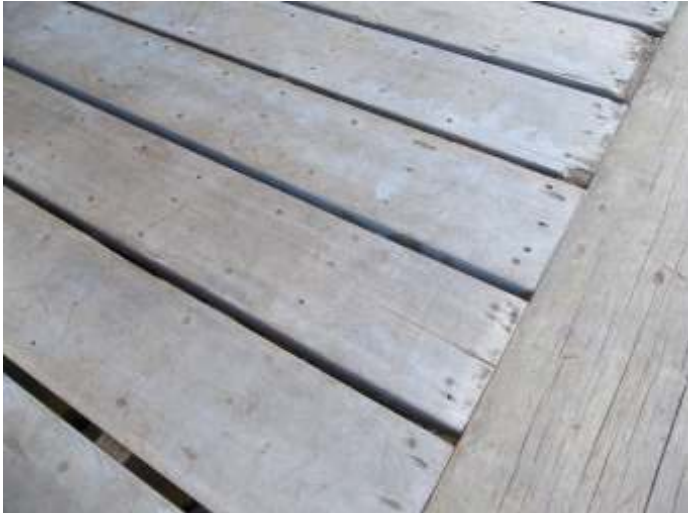
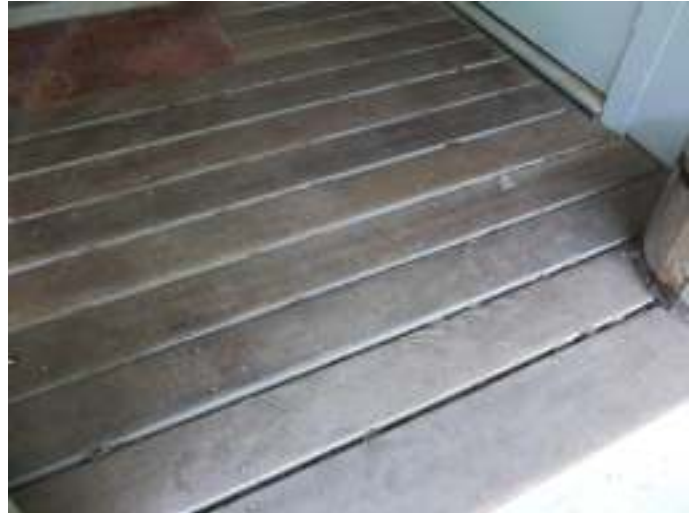
Comp #: 609 Unit Landings - Major Repairs

Landings appeared in fair condition at time of observation with only minor issues apparent at time of observation. We are recommending that the association reserve to restrain the decking every 3 years and feel that the decks will need significant repairs approximately every other restraining cycle in order to keep them safe and attractive.

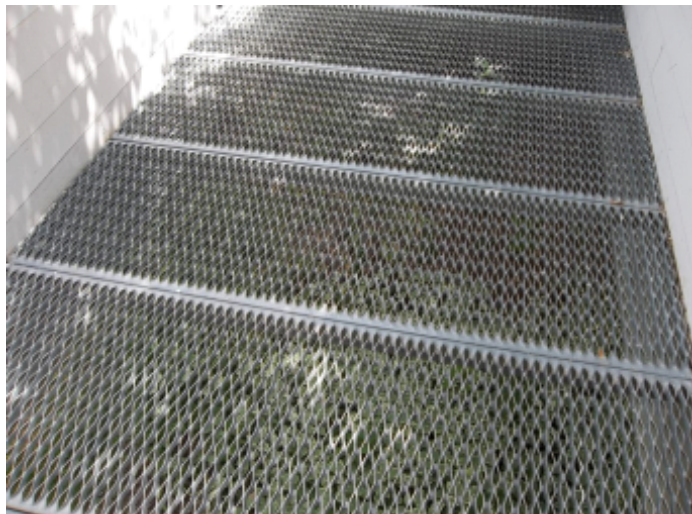
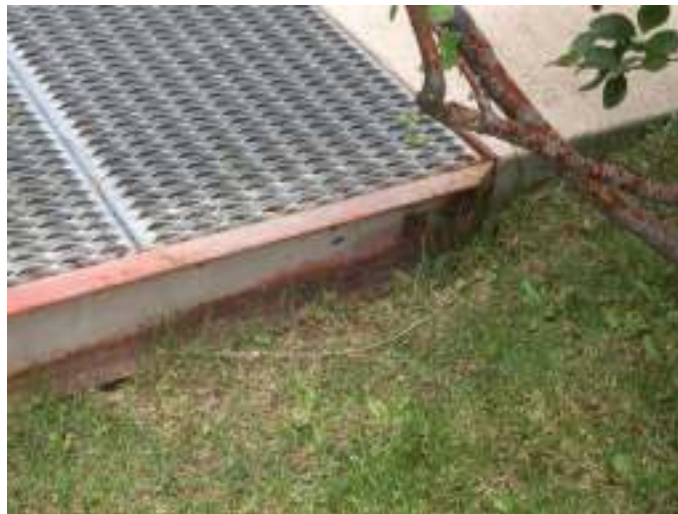
Comp #: 610 Steel Stairs/Landings - Replace

Steel grate components appeared in fair condition with some areas of rusting and oxidation noted at time of observation. These steel treads and landings have a long useful life, however, as this property ages it becomes increasingly important to begin reserving to replace the steel walkways and stairs due to the high cost for replacement. Expect to start replacing these stairs and landings within the next 9 - 11 years.

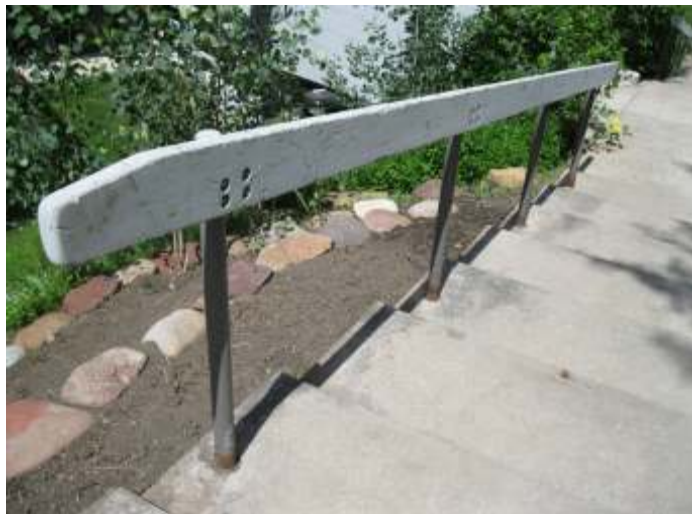
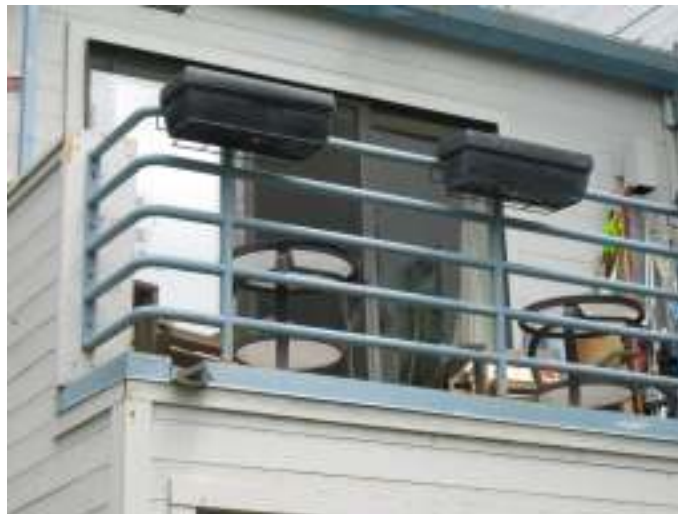
Comp #: 1001 Rail - Replace

Wood railings were bowed, aged in appearance and in need of some maintenance at time of observation. Metal rails show signs of some minor rust and oxidation. Due to the overall condition we recommend reserving to replace a percentage of the area every 5 years (10% or 140 LF) as we do not expect all railings will fail at the same time. Make minor repairs as needed between replacement cycles.

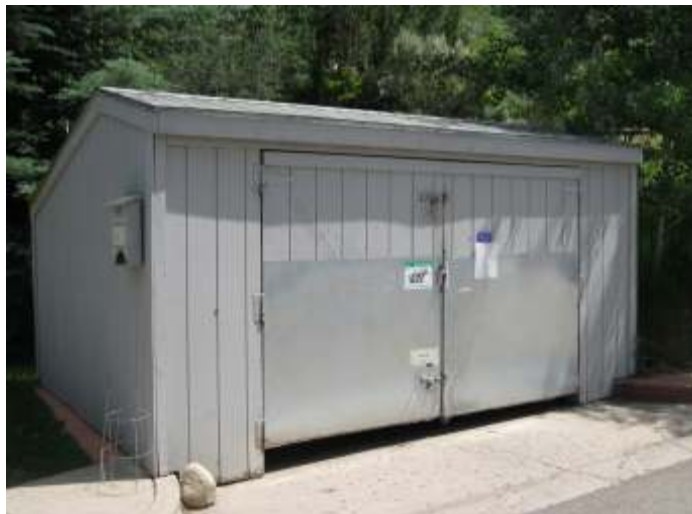
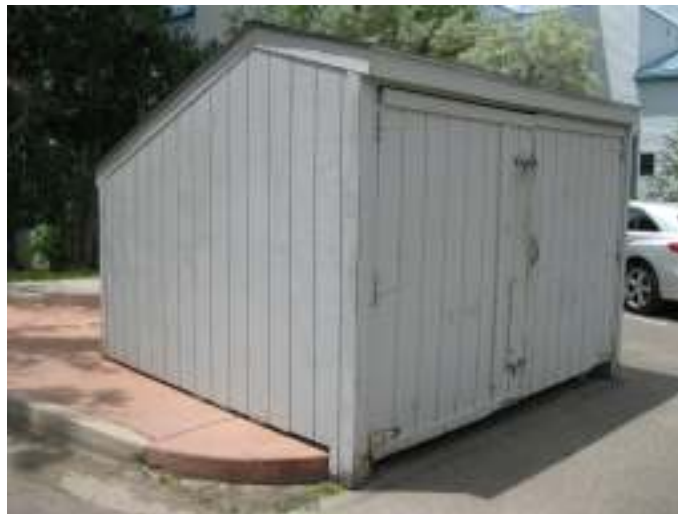
Comp #: 1010 Trash Enclosures - Rebuild

Trash enclosures appeared in fair condition at time of observation with minor damage apparent throughout structure. It is unlikely that the framing or roof deck will have to be replaced at any time during the scope of this report (30 yrs), however the finishes on the trash enclosures (siding, roofing, gates, etc.) should be replaced approximately every 20 years in order to maintain appearance and ensure safety for residents.

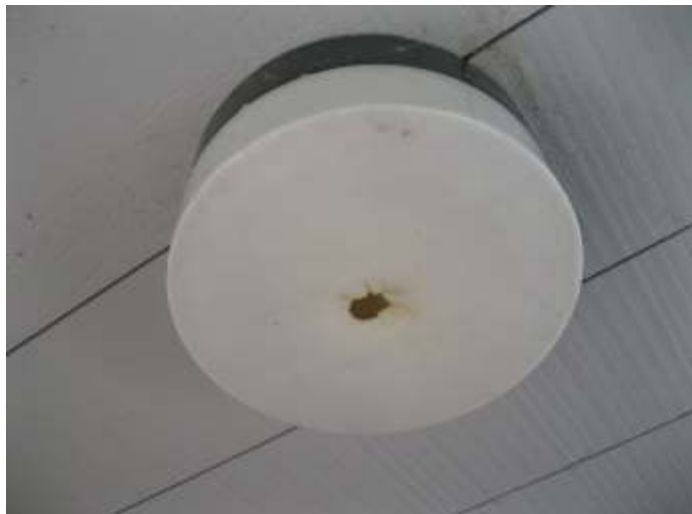
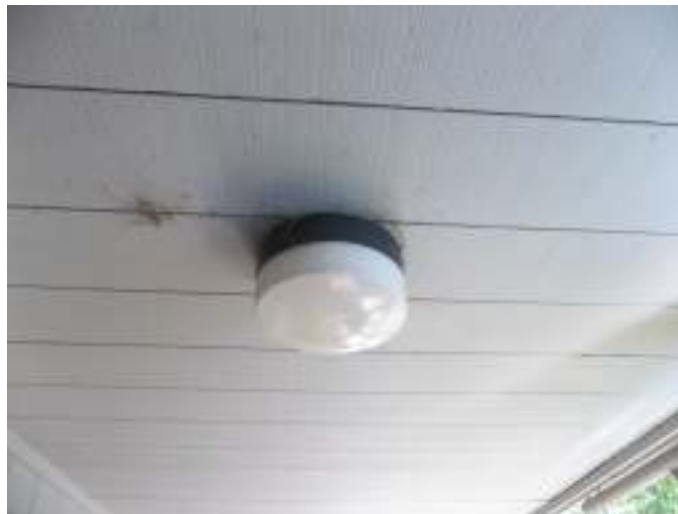
Comp #: 1602 Exterior Wall Mount - Replace

Lights are dated in appearance and should be replaced within the next 3 - 5 years. While replacement can occur on an as needed basis, it is our opinion and recommendation to replace all lights at the same time every 15 - 20 years to maintain a consistent appearance throughout the property. In addition, by replacing multiple fixtures, the association will be able to obtain a quantity discount for the fixtures. Estimated replacement cost includes labor for installation.
