Free Silver Court, Building 400 (page 2)

Free Silver Court, Building 300

Free Silver Court, Building 100

Teal Court, Building 200

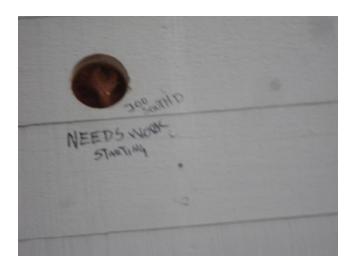
300 South B (not D)

Note: Picture on right is of siding leaking water. On the West side of Building 300

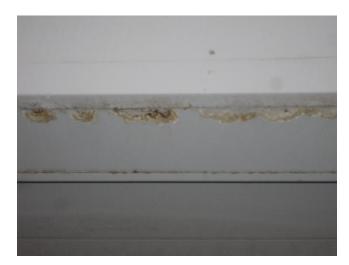
Note: The above pictures were taken at 300 West B sample. As you can see from the pictures there is rot and mold growing on overhang
