Centennial HOA Exterior Renovations  
Proposal.

BUILDING ENCLOSURE INVESTIGATION AND ANALYSIS  
CENTENNIAL CONDOMINIUMS  
ASPEN, CO

2011.02.21

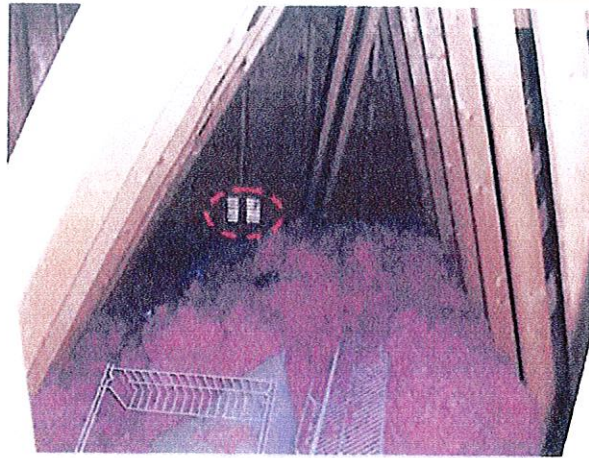
**Figure 10: Attic Vent from Interior**

The surveyed attic was accessed via a pull-down stair. The access hatch was not gasketed; it had been taped shut by the homeowner for air-sealing. In the attic, only one vent was observed (Figure 10). There may have been another similarly sized vent along the side wall on the southwest end of the attic.

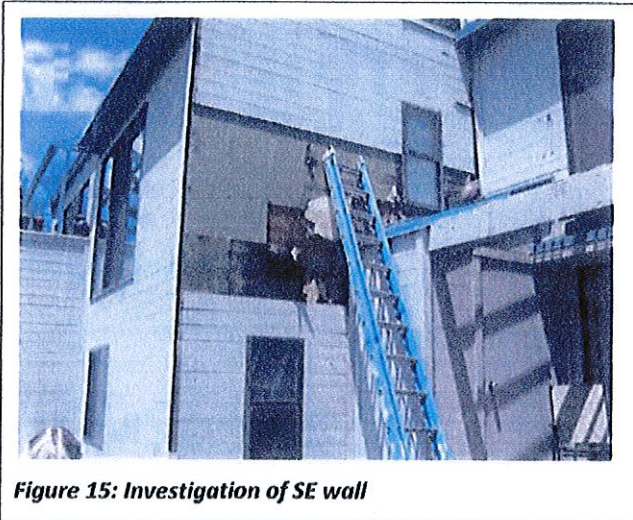
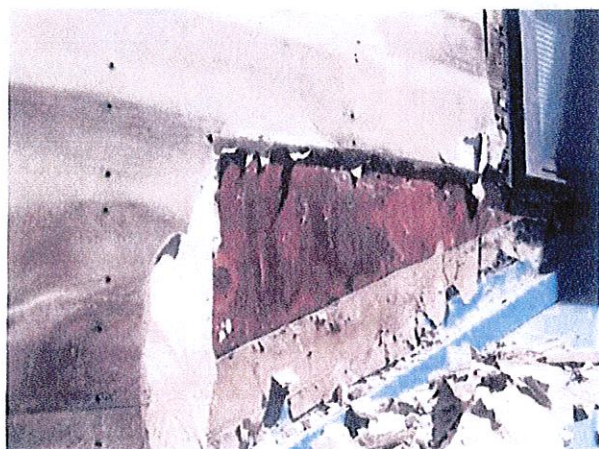
Many of the roof/wall intersections, especially on the southwest side of the buildings, showed evidence of peeled paint. Based on homeowner reports of water intrusion at exterior storage closets, a roof/wall intersection at one of the storage closets was selected for further investigation (Figure 15).

Upon removal of the siding, it was observed that the exterior gypsum board was water damaged along the sloped intersection of the wall and the roof. The exterior gypsum board was crumbling at the roof/wall connection. For several inches above the connection, the outer paper surface of the gypsum board was peeling away but the gypsum core remained intact. The plywood wall sheathing behind the gypsum board appeared undamaged. The water damage was more extensive towards the outer edge of the roof.

It was observed that the roof underlayment was turned up several inches and sealed to the exterior plywood wall sheathing. The connection between the metal deck and the wall sheathing was covered with a continuous bent sheet metal flashing. The sheet metal flashing was noted to be flashed back to the plywood wall sheathing. This places the flashing behind the exterior gypsum board (See Figure 16).

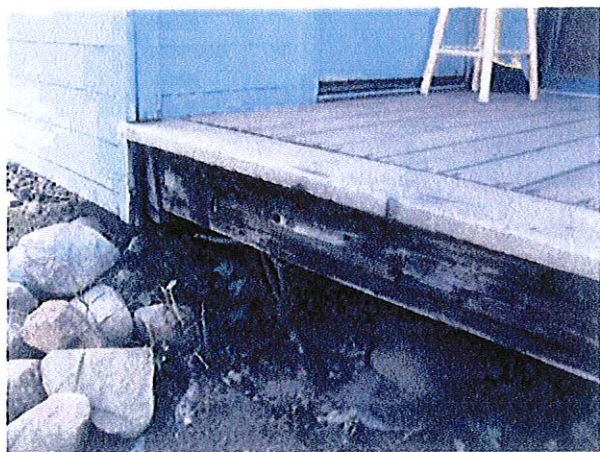
**Figure 19: SW porch deck**

It should be noted that the first floor decks on the southwest side of the buildings were originally constructed as cantilevered structures. There was water damage reported in the past at the decks –all the original stairs were removed because of damage – and damage can be seen to the some of the structure underneath. (See Figure 19) In some cases, homeowners have added support underneath suggesting that the original decks may be sagging. (See Figure 20)

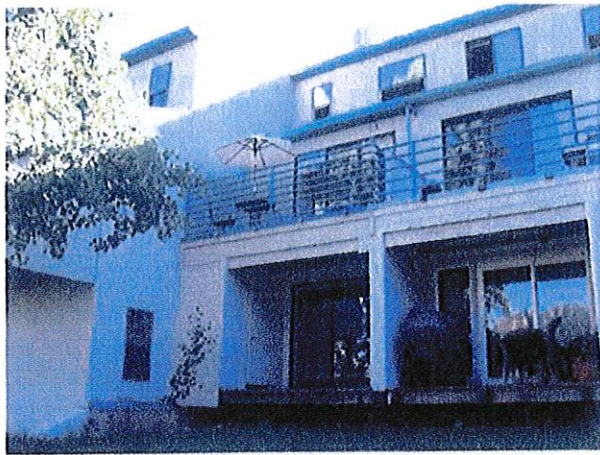
**Figure 21: Example of deck over storage closet**

Some homeowners have added decks at the second floor on the southwest side. By doing so, they replaced the original roof structure at the exterior storage closets below. Figure 21 shows an example of this.

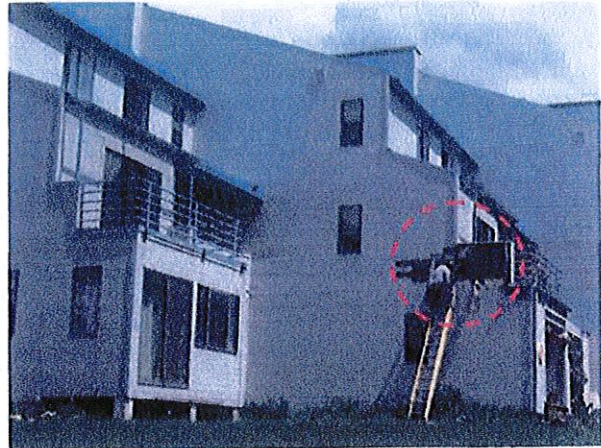
**Figure 22: SW porch with added**

It was reported that there has been water intrusion in the storage closets with modified construction as well as in the original construction. Therefore a disassembly investigation was performed at the wall along one such deck. (See Figure 22) In this case, the original sidewall was extended up to form a wing wall for the 2<sup>nd</sup> floor deck. Siding was removed from the wing wall to check for water damage which can be seen on the exterior gypsum board at several places (Figure 23). A cut was

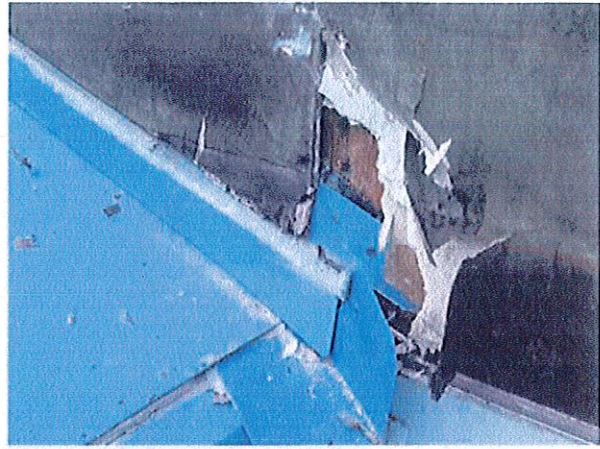
**Figure 26: Detail at roof/wall**

The next field disassembly was located at a roof/wall intersection along the northeast side of the building (Figure 25). The siding was removed so the condition of the wall could be examined (Figure 26). There was some water staining on the face of the exterior gypsum board causing peeling of its outer layer but the core was not damaged. The gypsum board was broken off to look at the plywood behind, which was not damaged. The roof/wall flashing detail was similar to that described earlier.

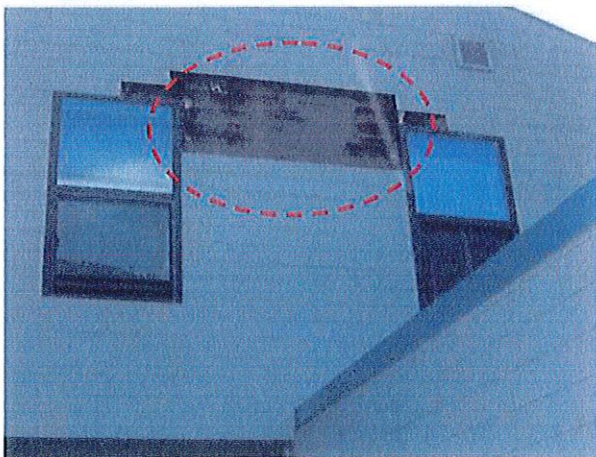
**Figure 27: Investigation at NE wall (field)**

Additional investigation openings were made at two locations – in the wall field on a northeast wall and on a southeast wall. At the location on the northeast wall, when the siding was removed, some water stains could be seen on the face of the exterior gypsum board at siding nail penetration and around the windows, but there was no deterioration (See Figure 27). It should be noted that there is no overhang over this wall. On the other hand, along the southwest wall, where there is an overhang, no water staining of the exterior gypsum board was observed (See Figure 28).

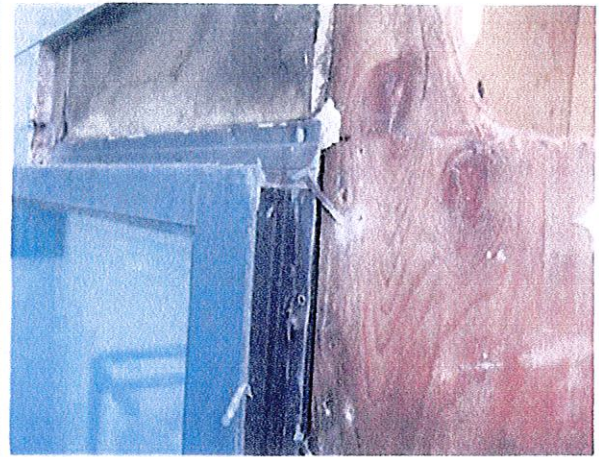
Figure 30: Investigation at window (NE wall)

The windows from the original construction are still in place. They are double glazed windows and some are reported to be experiencing condensation within the glazing. The siding was removed at a window on the southwest side of the building (on a southeast facing wall) and at a window on the northeast side of the building to check for water damage around the windows (See Figure 29 and Figure 30). In both cases, the windows are on walls for which there is no overhang. There was no flashing observed at the windows (this lack of flashing was also noted at door heads, louvered vents, and mechanical penetrations). There was some water staining on the exterior gypsum board around both of the windows and on the plywood behind. The plywood was cut at the window on the northeast side to check for damage inside the wall, but none was observed.

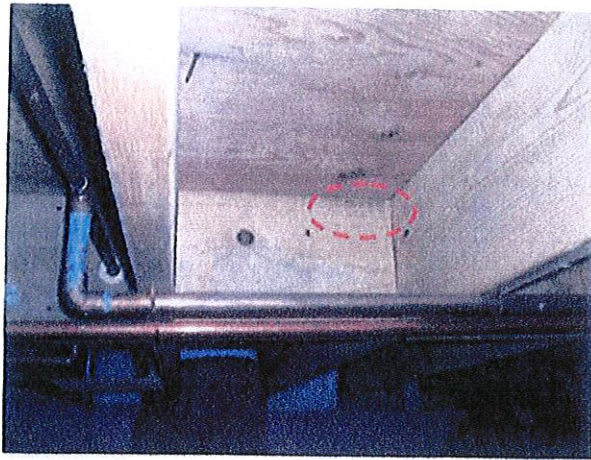
Figure 33: Piping in Basement

In general, the subfloor and framing was clean and free of water staining. However, there was occasional evidence of condensation. This can be seen on the blocking above plumbing pipes in Figure 33. There was also evidence of condensation along the rim joist (See Figure 34). No structural water damage was observed on the floor framing or on any portions of the rim board that were examined.

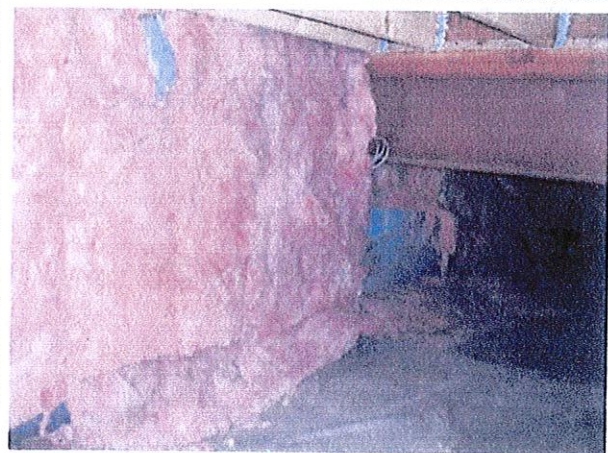
Figure 36: Foundation wall insulation

The walls of the crawlspace are insulated with a layer of XPS against the concrete foundation wall which is covered with a blanket of fiberglass insulation. The crawlspace floor has a continuous ground cover of polyethylene. The ground cover is sealed to the footing at the interior columns (Figure 37) and is sealed to the XPS at the walls (Figure 38).

The crawlspace vents were difficult to locate and were partially covered with fiberglass insulation. Where the vents could be seen, the free area was limited. Observations provided by REG indicated that some vents were blocked with XPS.

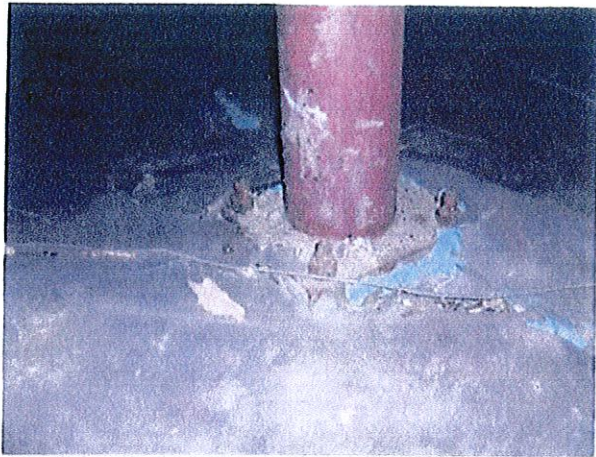
**Figure 37: Poly ground cover at lally column**

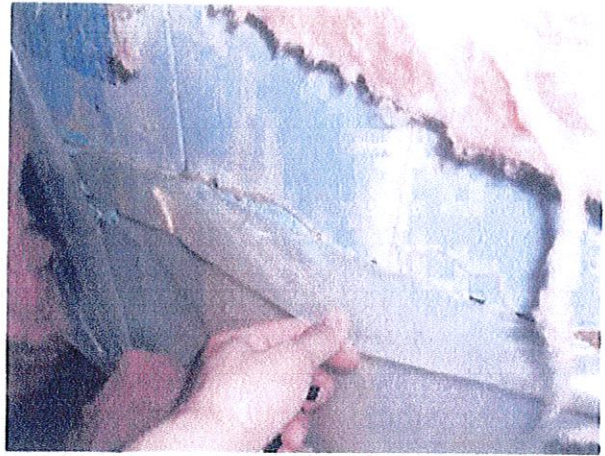
**Figure 38: Poly ground cover sealed to wall insulation**

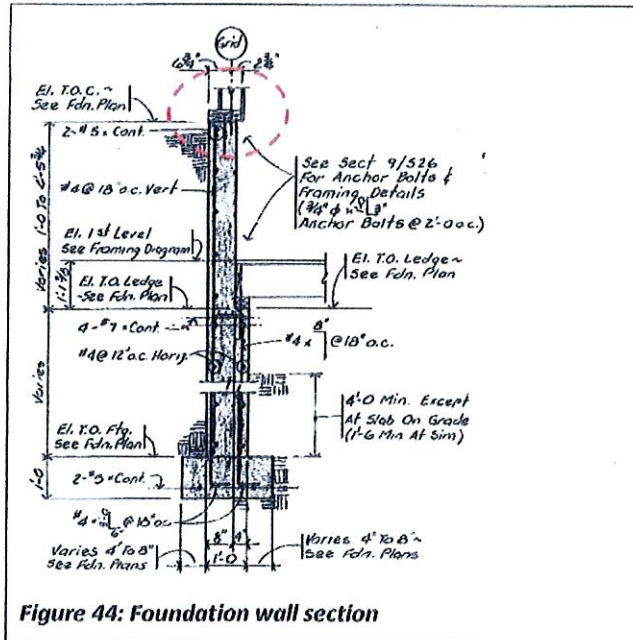
Figure 44: Foundation wall section

The leakage at the roof to wall connections is resulting in damage of the first floor structure where the wood frame structure is connected to the concrete foundation. The buildings are designed with the framing set back from the exterior edge of the foundation wall (Figure 44). This created a ledge for the water to accumulate at the base of the wall assembly. Removal of the siding material at the base of the southeast facing wall during the field investigation revealed that the framing had deteriorated (Figure 45).
