CENTENNIAL CONDOMINIUMS Concept Study

March 24, 2010

- Existing Conditions of the Complex
 - Inadequate Construction
 - Design Flaws
 - Value Engineering

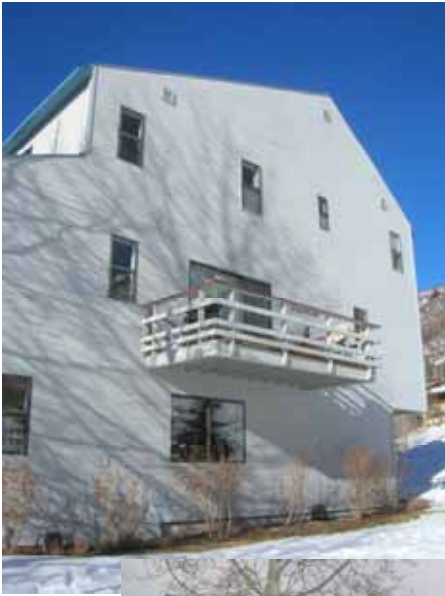
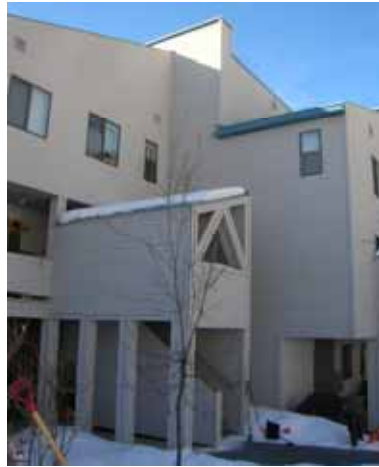
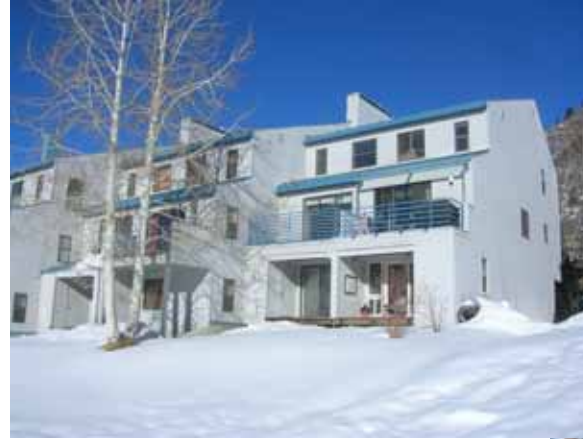
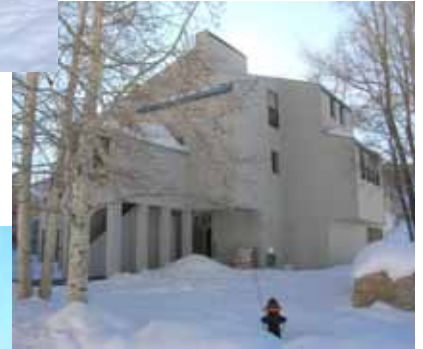
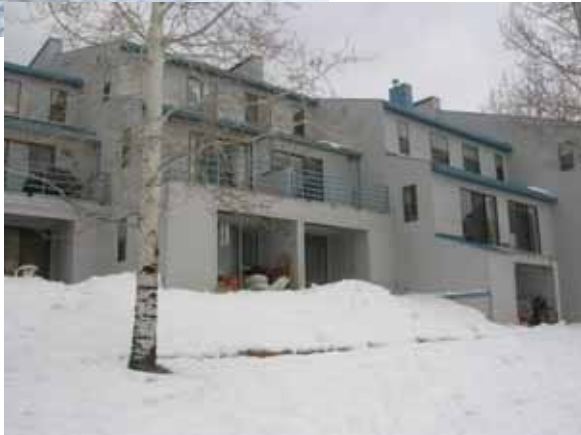
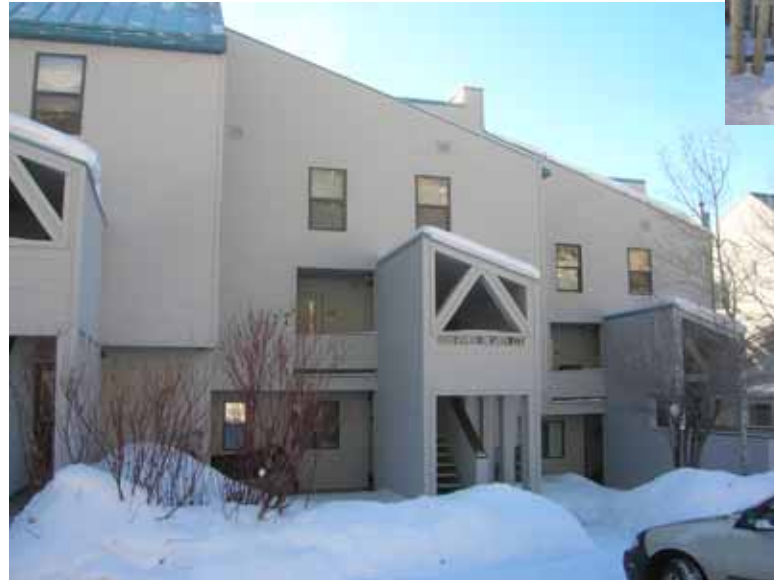
Sub Standard Roof and Flashing Installation

No Flashing installed at Windows and Doors

Inadequate Counter Flashing and Bituthene at Roof Transition

No Felt or Building Paper installed behind horizontal Tongue & Groove Siding

Snow and Rain Drop Zones create areas where water sits or splashes up against Building
