**Centennial Owner's Association**  
**100 - 400 Free Silver Ct. & 200 - 400 Teal Ct.**  
**Aspen, CO 81612**

**Level 1 Reserve Analysis**

**Report Period – 01/01/13 – 12/31/13**

**Date of Property Observation - June 25, 2012**  
**Project Manager - Matthew Woytek**  
**Main Contact Person - Mr. Russell Shaffran, Board of Directors**

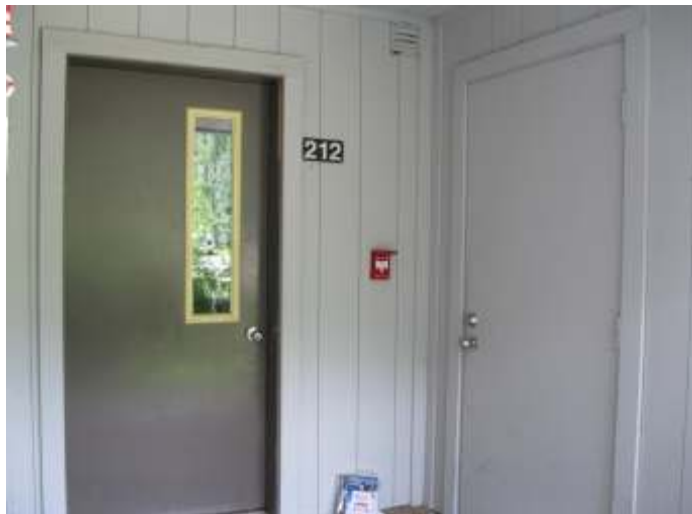
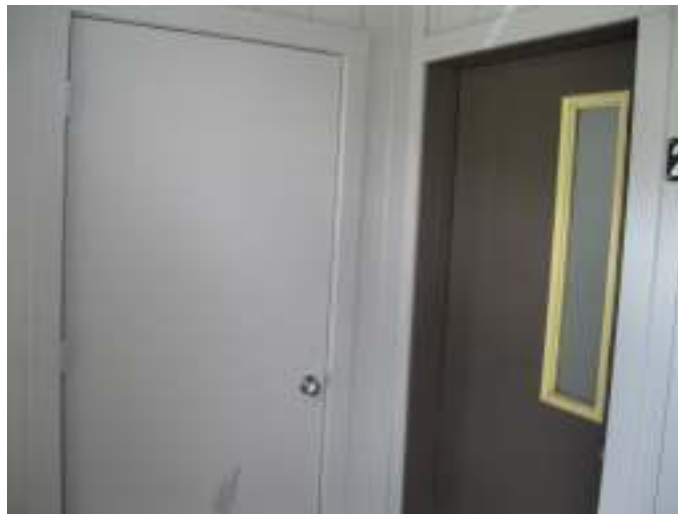
Comp #: 501 Doors - Replace

It was reported by client that the doors are the responsibility of the individual owners, therefore, no reserve funding recommended at this time.

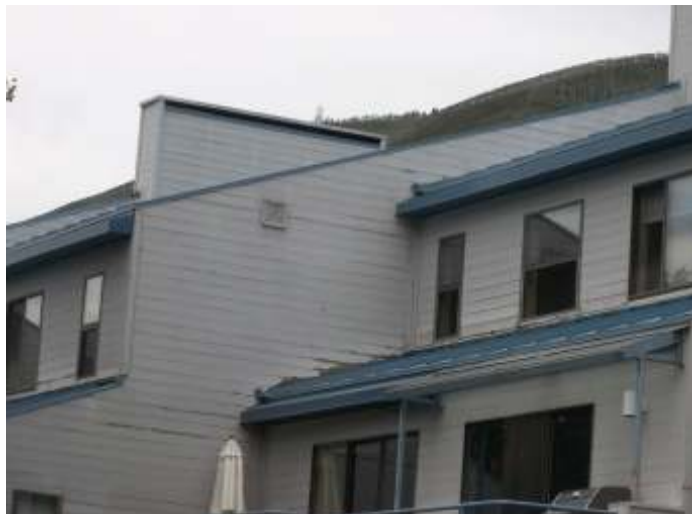
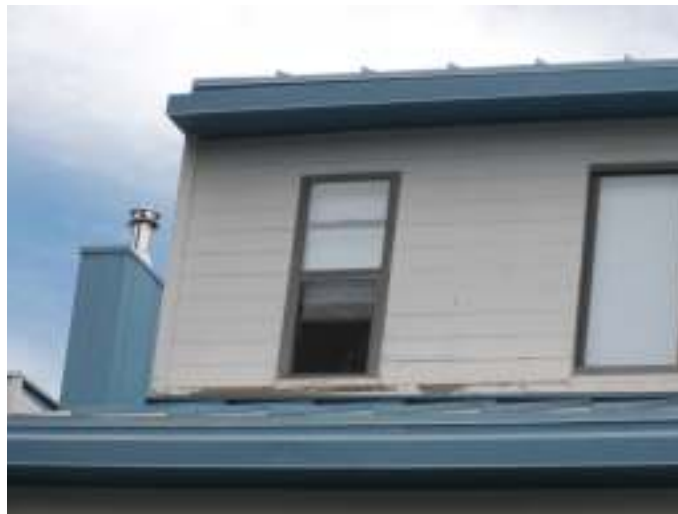
Comp #: 506 Windows - Replace

Similar to community doors, it was reported by the client that the unit building windows are the responsibility of the individual homeowner. No reserve funding necessary at this time.

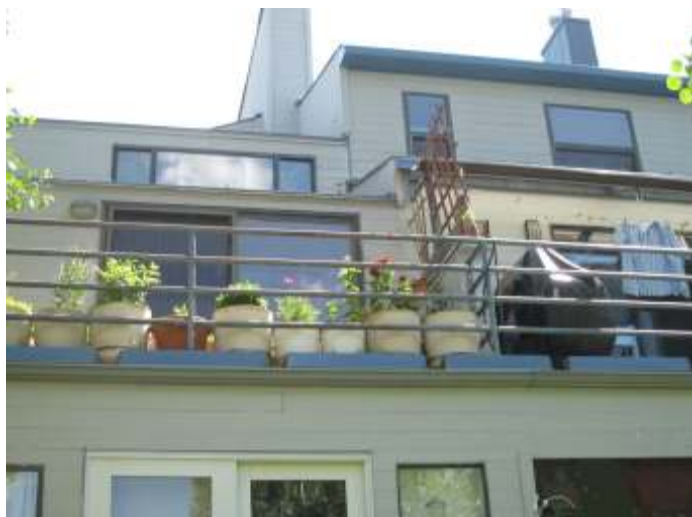
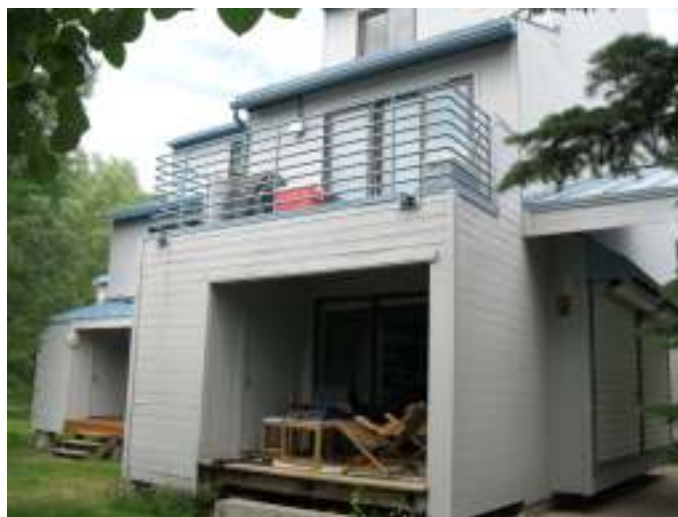
Comp #: 607 Upper Rear Decks - Major Repairs

Due to privacy issues, we were unable to observe the conditions of the upper decks. However, based on reported information from the client, there are concerns that the upper decks have water intrusion problems related to their reported, current state of repair. Therefore, we recommend that the association reserve to make major repairs every 4 years in order to ensure proper function of water mitigation, safety to the homeowner and appropriate appearances. If deterioration rates change, we can adjust quantity or frequency of repairs in future updates of this report.

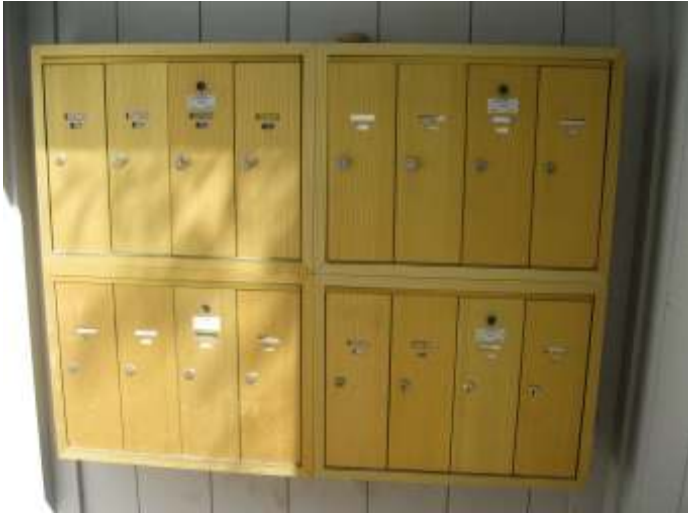
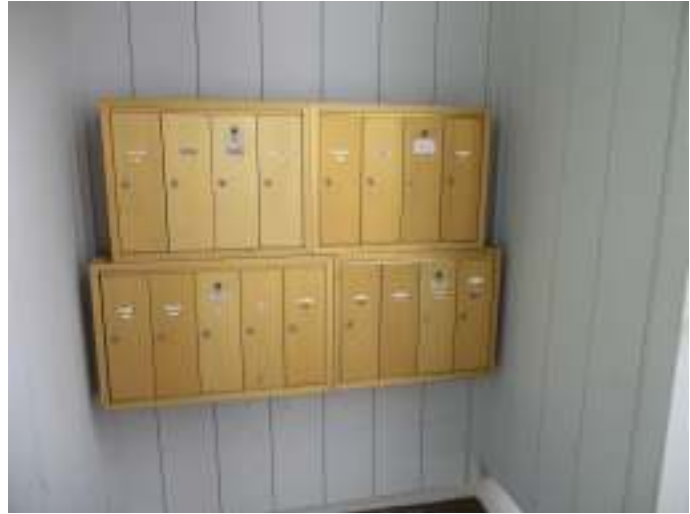
Comp #: 803 Mailboxes - Replace

These cluster box units are standard and are available for retail purchase. The individual cost for replacement is not enough for separate reserve allocation, however, in order to keep a consistent appearance throughout the community, we recommend reserving to replace all mailboxes at the same time.

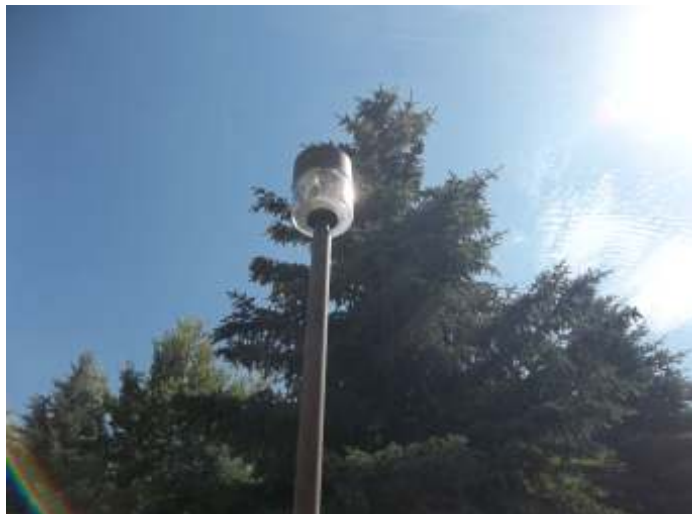
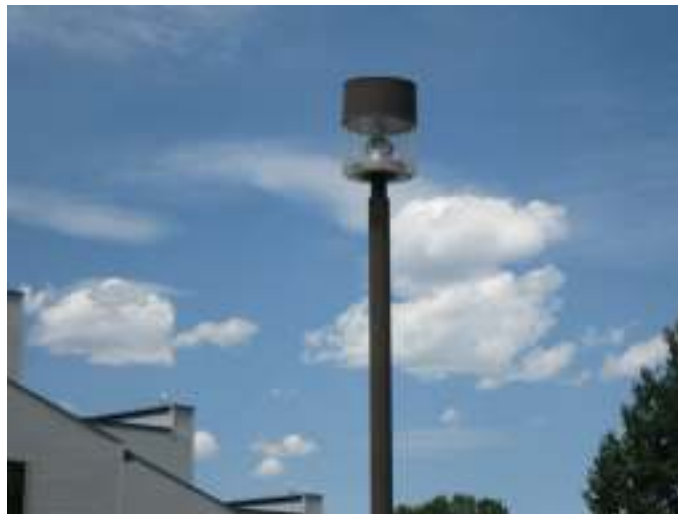
Comp #: 1604 Pole Lights - Replace

No structural problems noted with lights at the time of observation. Due to the extended life associated with light poles reserve funding is not appropriate. Reserve only to replace fixtures on a 20 year schedule to maintain appearance and function.

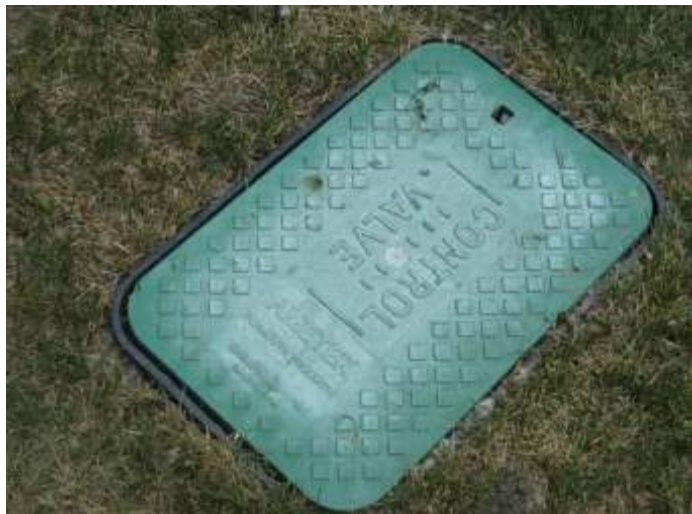
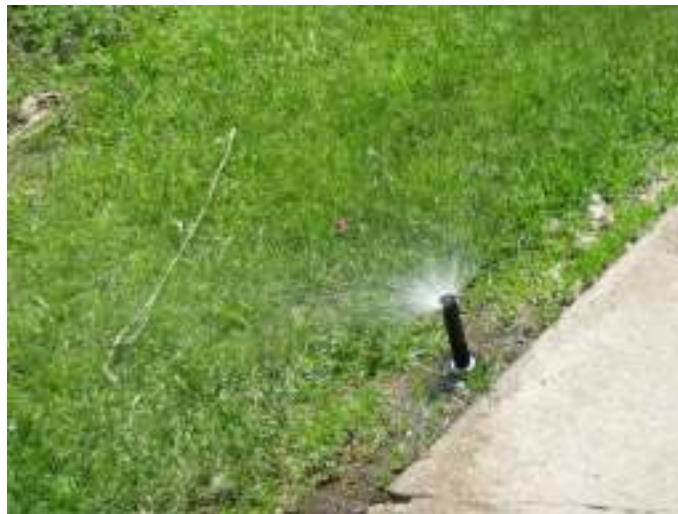
Comp #: 1701 Irrigation System - Major Repairs

No problems reported in regard to the irrigation system at time of preparing this report. This line item and the funding herein is to address problems that happen to the irrigation system that require more scope of work than routine maintenance. As tree and shrub roots mature, it is common for them to impinge on lateral lines causing significant damage to the system. Progressively reserve for irrigation system repairs rather than reacting to an emergency project which drives costs up significantly.

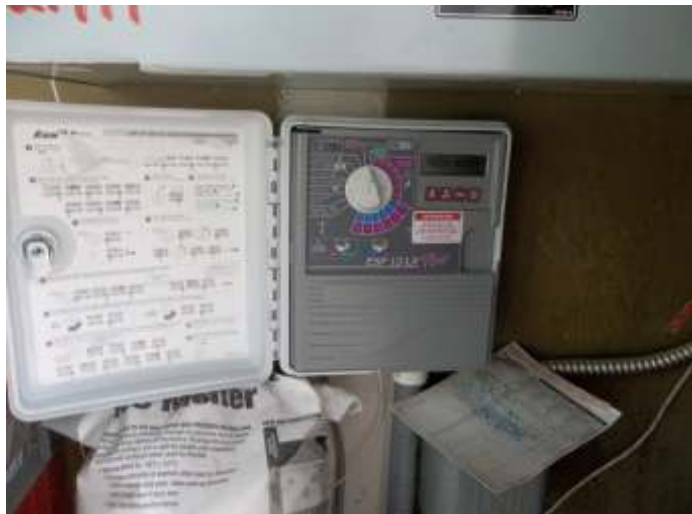
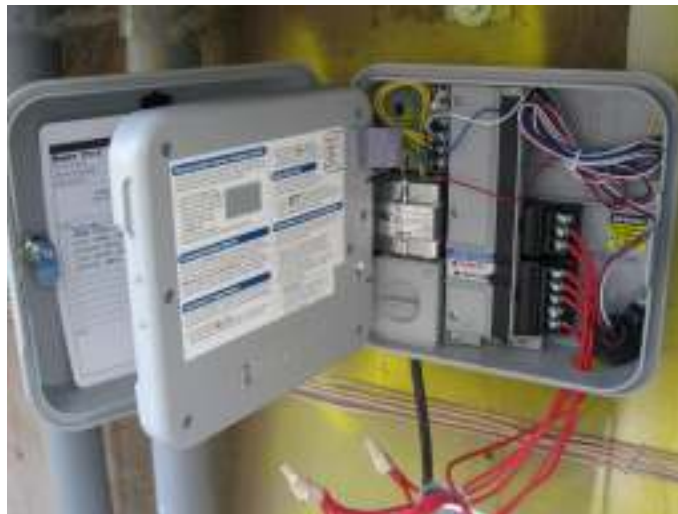
Comp #: 1703 Irrigation Timeclocks - Replace

No problems reported while preparing this report. Under normal conditions (not including Acts of God, vandalism, etc.) these clocks should last 10 - 12 years with proper maintenance. Due to advances in technology and water efficiency, we suggest reserving to replace all clocks at the same time. A lot of communities are upgrading to ET type controllers and the costs reflect this. Remaining useful life based on average age of all clocks.
